Grantham Floods Commission of Inquiry

Submissions of West Grantham Residents

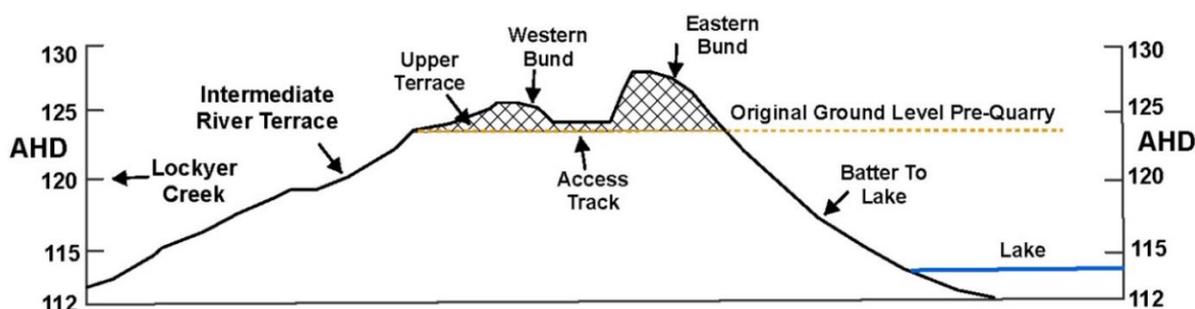
Plate1: Schematic cross-section through western levee, Grantham Quarry

Inset: Exert from the report of Mr Starr depicting the western embankment / levee

21. Contrary to the submissions made by the Wagners, the report of Mr Starr found that the eastern bund on the western embankment was approximately 4 metres in height above the natural ground level and varied between 2 metres to 6 metres.¹¹

22. With the assistance of test pit 113, which was located on the eastern bund, Mr Starr found that the construction of the bund probably developed over time in stages.¹² Mr Starr found that the construction of the bunds either side of the access track along the western embankment of the quarry site commenced after August 1997 and before June 2001, and the levees construction continued from 2001 until about 2005.¹³

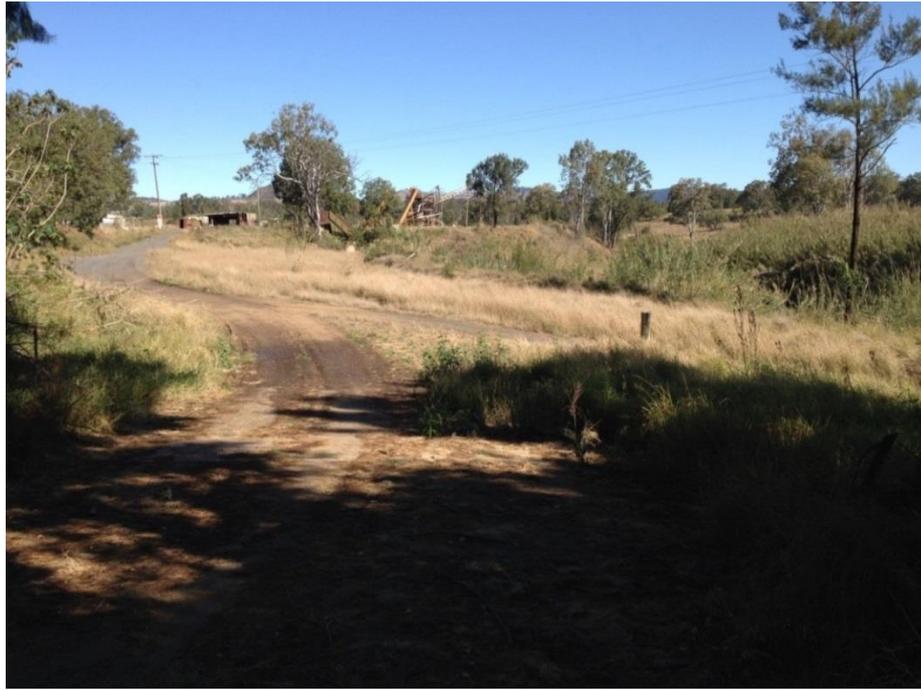
Inset: Dip in topography from gate to quarry along the Access Track. Date: Friday, 28 August 2015

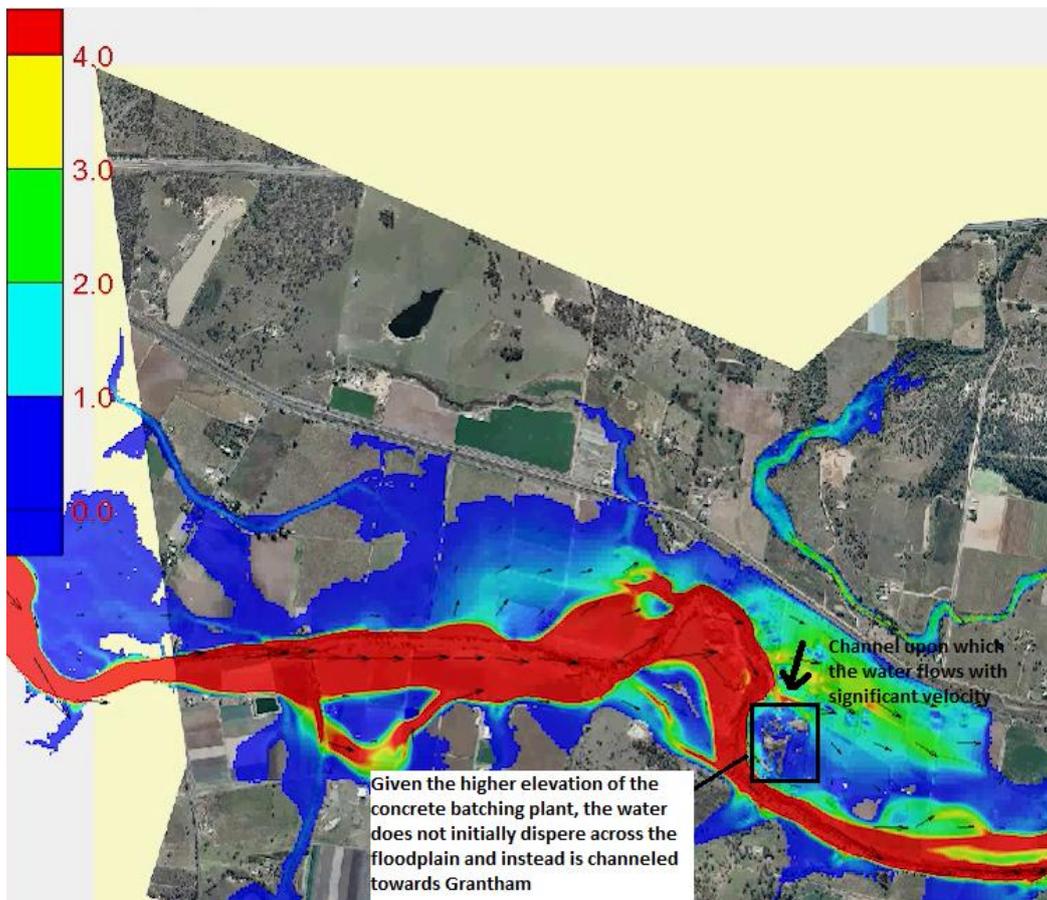
Inset: without quarry scenario at 4.00PM

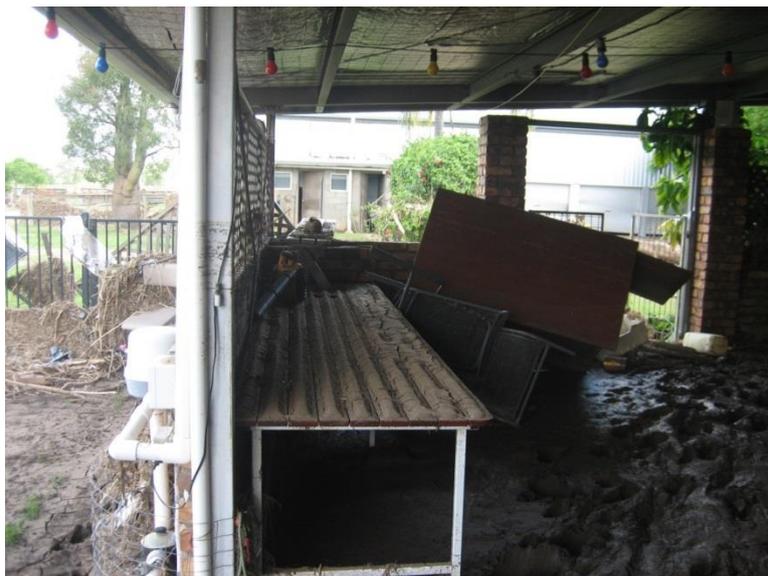
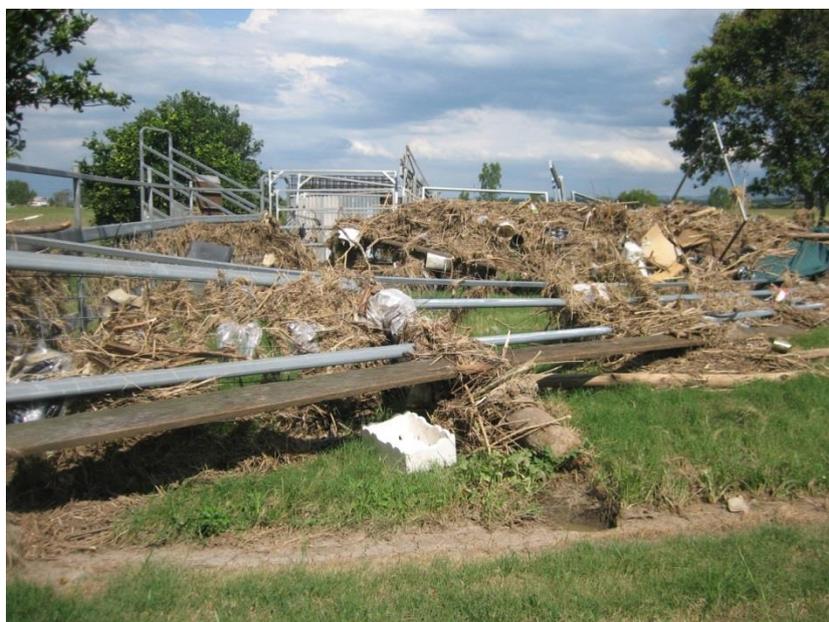
56. Dr Macintosh states that if a debris flow occurred, there would have been a substantial amount of debris left around.⁴⁶ Dr Szykarski said we would see "sludge" left behind.⁴⁷ We note that multiple West Grantham residents have described significant amounts of debris, sediment and sludge left at their properties as depicted in the below photographs.

Inset: Photograph supplied by John Gallagher – Gallagher’s residence
