GRANTHAM FLOODS COMMISSION OF INQUIRY

Submissions on behalf of the 'Grantham Families'

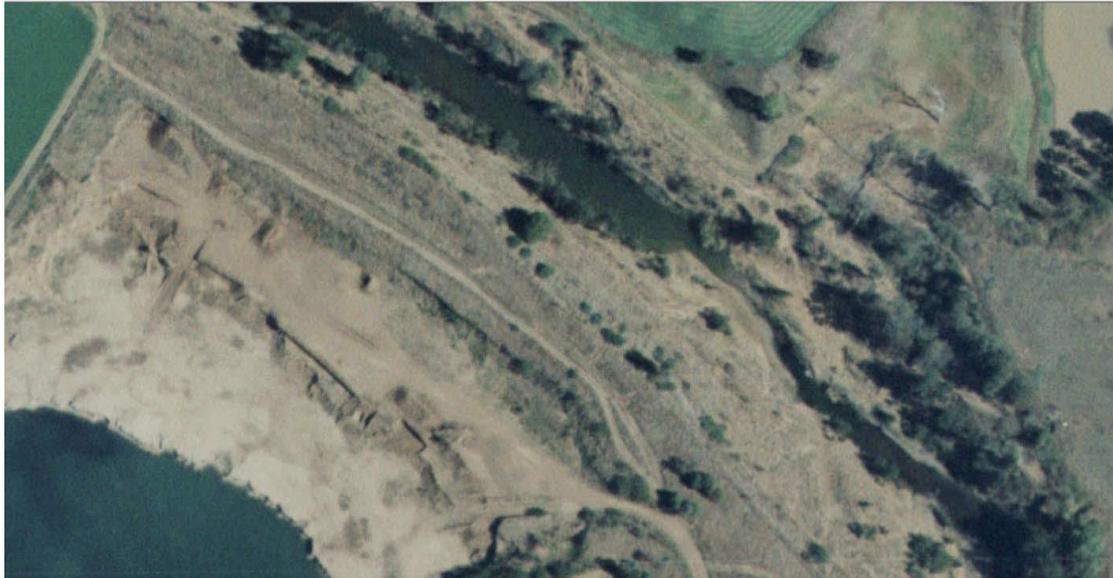
'Enlargement of 1997 air photo showing western levee – note no bunds either side of the access track.

20. Dr Starr's evidence was based on his stereo-analysis of aerial photographs and examination of the remnants of the bund walls on the site. He gave the opinion that the substantial bund walls on the western bank of the quarry were built between 2001 and 2008. He indicated that a comparison between 1997 and 2001 aerial photographs and later photographs from 2008 (and LIDAR from 2010) demonstrated that the bund walls which existed by 2010, did not exist in 1997 or 2001.¹³

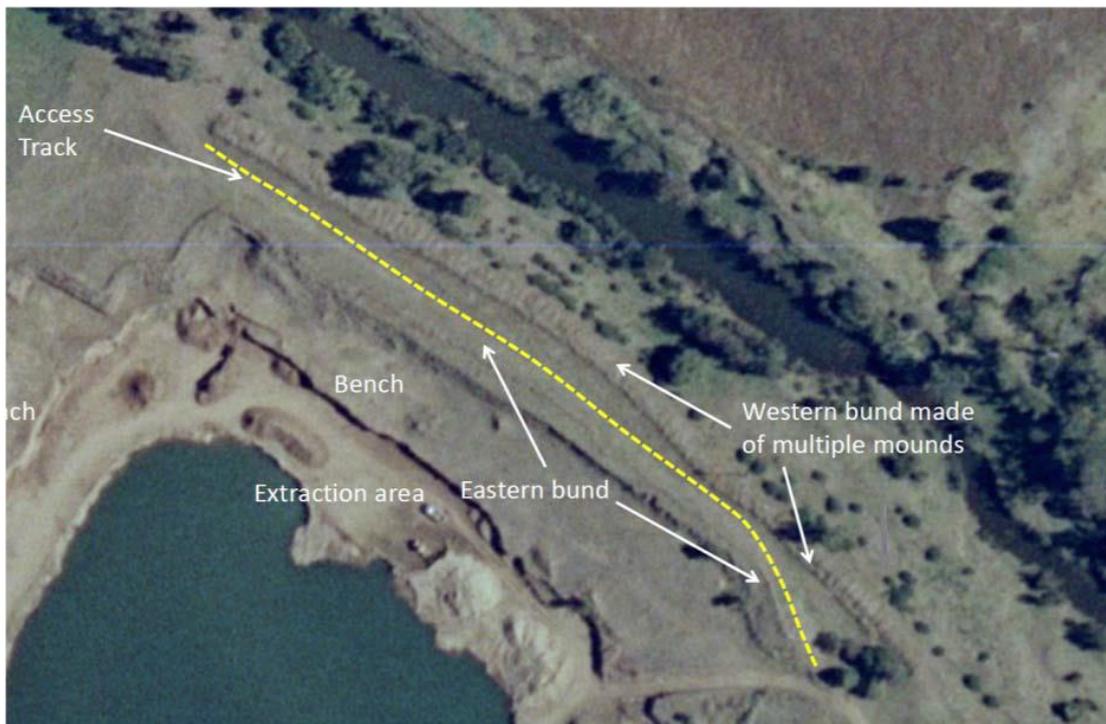
'Enlargement of 2001 air photo showing western levee – note multiple mounds of earth on west side of the access track.

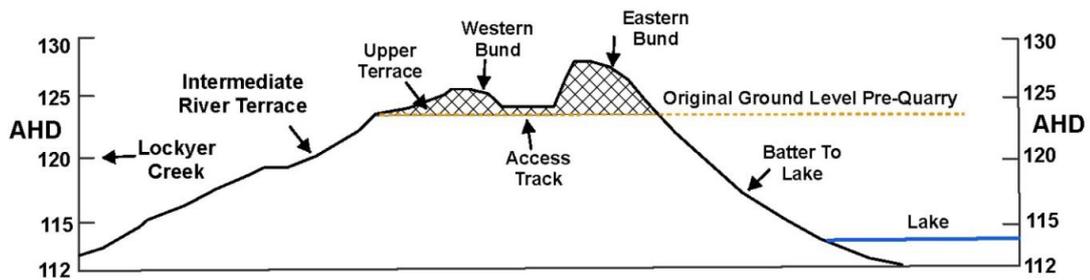
‘Schematic cross-section through western levee, Grantham Quarry’.

21. Mr Anthony McIntosh's evidence was that it was in about 2005 that the level of the walls on the western side of the quarry pit *"was being raised much higher."*¹⁴ Dr Starr's assessment of the state of the bunds on the western side of the quarry is set out in a schematic way in the first plate of his report.
