**GRANTHAM FLOODS COMMISSION OF INQUIRY**

**EXPERT HYDROLOGY REPORT  
10 JANUARY 2011 FLOOD**

**CIRCUMSTANCES AND CONTRIBUTING  
FACTORS**

Job Number	WS0854.1501.001
Doc Number	WS150262
Revision	0
Date	11 August 2015

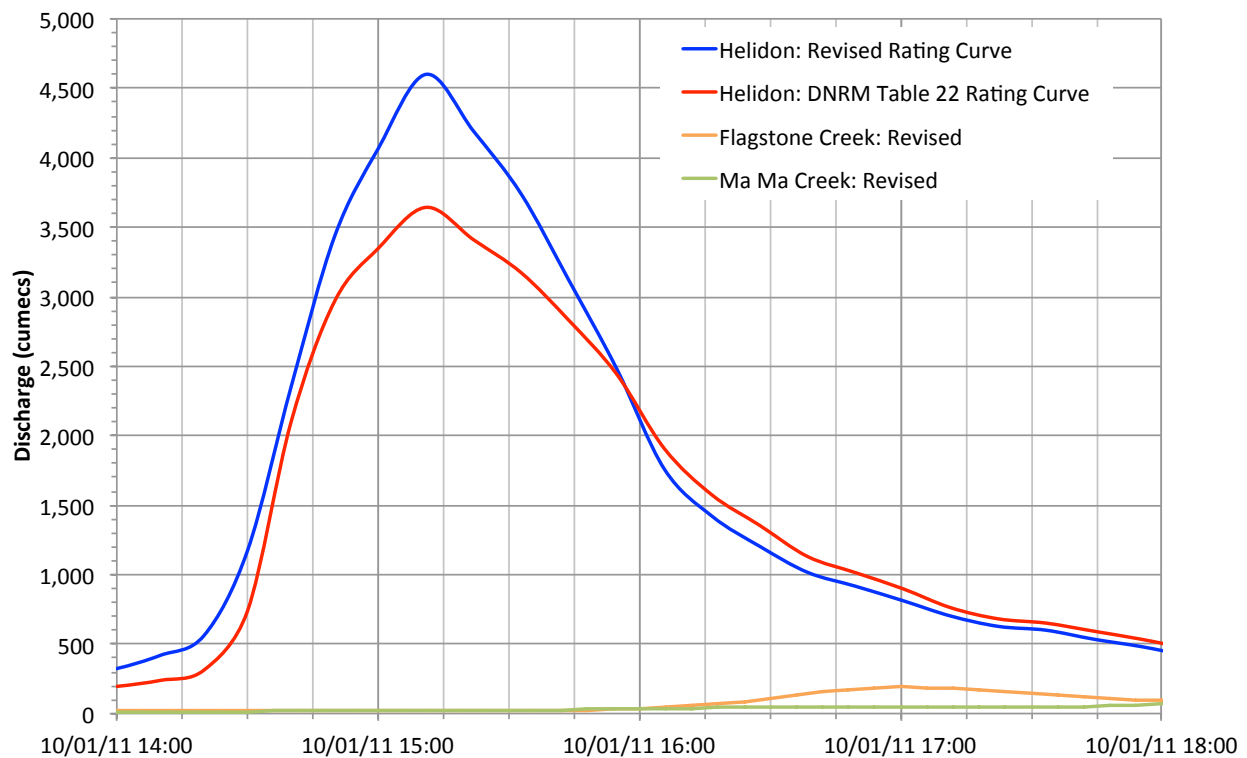
**Figure 1.6 – Revised Flow Hydrographs at DNRM Gauging Stations**

19. For the reasons set out in Section 8.3, I considered that it was necessary for me to derive revised flow hydrographs for the DNRM Gauging Stations at Helidon (Lockyer Creek), Flagstone and Ma Ma Creeks. I have plotted these revised hydrographs in Figure 1.6 below.

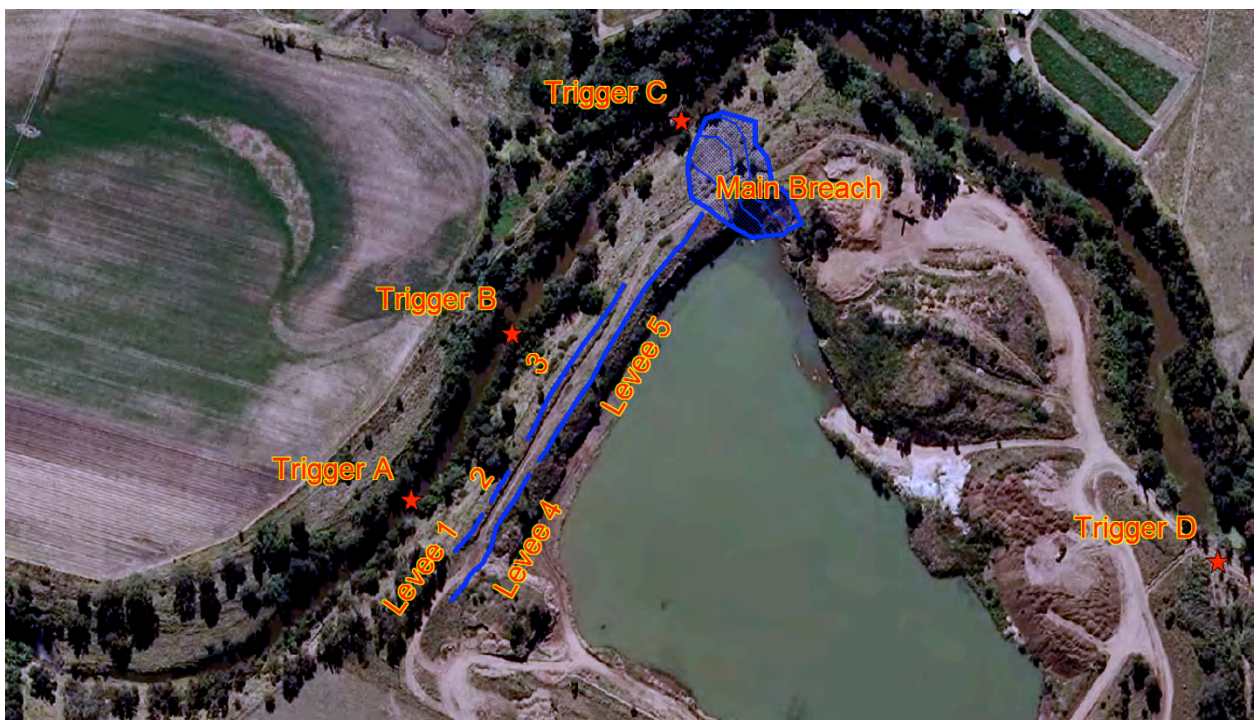
**Figure 1.8 – Quarry Failure Trigger Level Locations**

26. I have then chosen trigger locations at three points (A, B, C) as indicated in Figure 1.8 below. I have associated these triggers to individual bunds (shown as Levee 1 to 5) also shown in Figure 1.8. When flood levels reach the same height as that of a trigger it will cause the start of simulated erosion of the associated bund. For example, when the water level reaches the trigger level for location C simulated erosion will then commence at the Main Breach. I have provided in Appendix B.6 a table that specifies the flood level for each trigger location and the corresponding time of trigger.
27. Due to the difference in heights at locations A, B and C triggering will occur at different times and bund erosion will occur progressively.

28. The trigger heights have also been set so as not to trigger until the levees as depicted in Figure 1.8 above have been overtopped. I have done this in consideration of the rapid rate of rise of the flow hydrograph, which I consider would most likely result in the occurrence of a top down erosion breach of the Western Levee.

37. I have chosen a single location point (D), also as indicated in Figure 1.8 (see previous page), to identify the trigger height for initiating failure of the entire Western Levee. The significance of location D is its close proximity to the point of the breakout of overbank flows from this location eastward to Grantham (Western Overbank flows) as indicated by Mr and Mrs Besley in their eyewitness accounts.

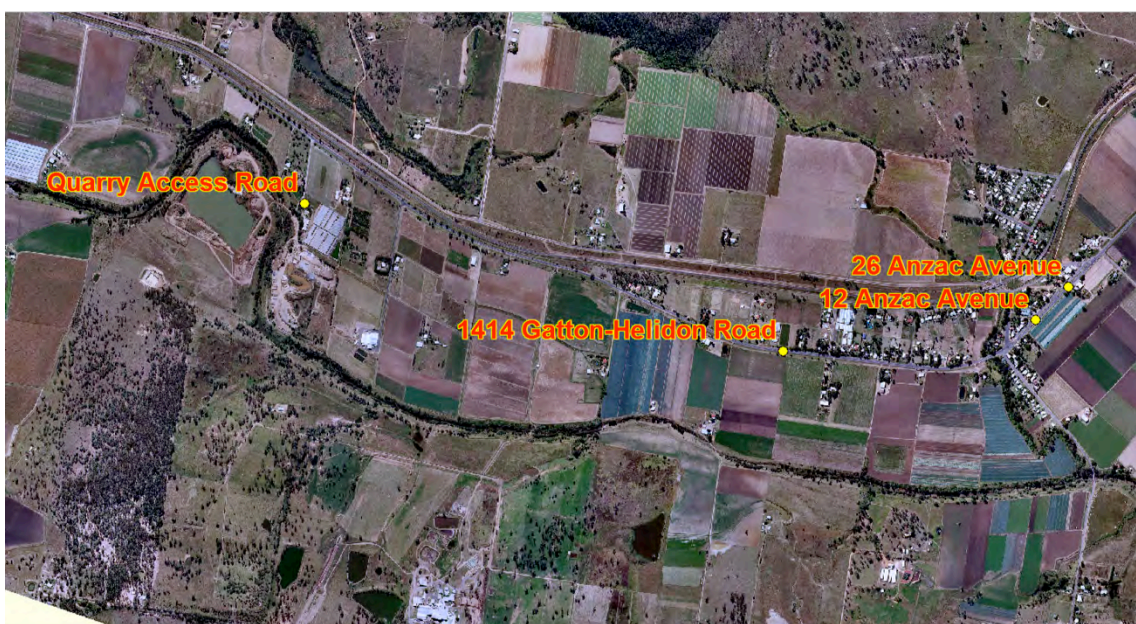
**Figure 1.9 – Flow Depth and Intensity Locations**

39. My simulations analyses considered a range of Western Levee failure initiation times:
- Most Likely Case at 3:25pm;
  - Worst Case (greatest drop) at 3:35pm; and
  - Worst Case (greatest delay) at 4:16pm.
40. In addressing the outcomes of my sensitivity analyses I have considered the following simulated flooding characteristics:
- time of inundation;
  - flow depth and intensity (product of velocity and depth); and
  - rate of increase in flow depth and intensity.
41. I have reviewed these characteristics at selected locations that I consider give representative coverage of flooding within and around Grantham. These locations are indicated in Figure 1.9.

42. I have extracted key simulation outcomes for the selected locations identified in Figure 1.9 above and summarised these in Table 1.2 below. For the purposes of this summary I have combined the flow characteristics of depth and rate of increase in depth by way of a single point of measure being the time taken to reach 0.5m. I have applied the same for flow intensity, but used  $0.5\text{m}^2/\text{s}$  as a point of measure.
