## **2 Introduction**

85. The Grantham Floods Commission of Inquiry (the GFCOI) was established under the *Commissions of Inquiry Act 1950* to make full and careful inquiry into the flooding of Lockyer Creek between Helidon and Grantham on 10<sup>th</sup> January 2011.
86. I have been engaged by the GFCOI to provide an expert hydrology opinion in relation to:
- the likely chronology of the flooding between Helidon and Grantham on 10<sup>th</sup> January 2011; and
  - the possible factors that may have altered, contributed, caused or materially impacted on the flooding on 10<sup>th</sup> January 2011 with specific reference to any natural or man-made features of the landscape, and in particular the Grantham Quarry.
87. In forming my opinion I have been requested to consider the matters set out in four letters of instruction contained in Appendix E.

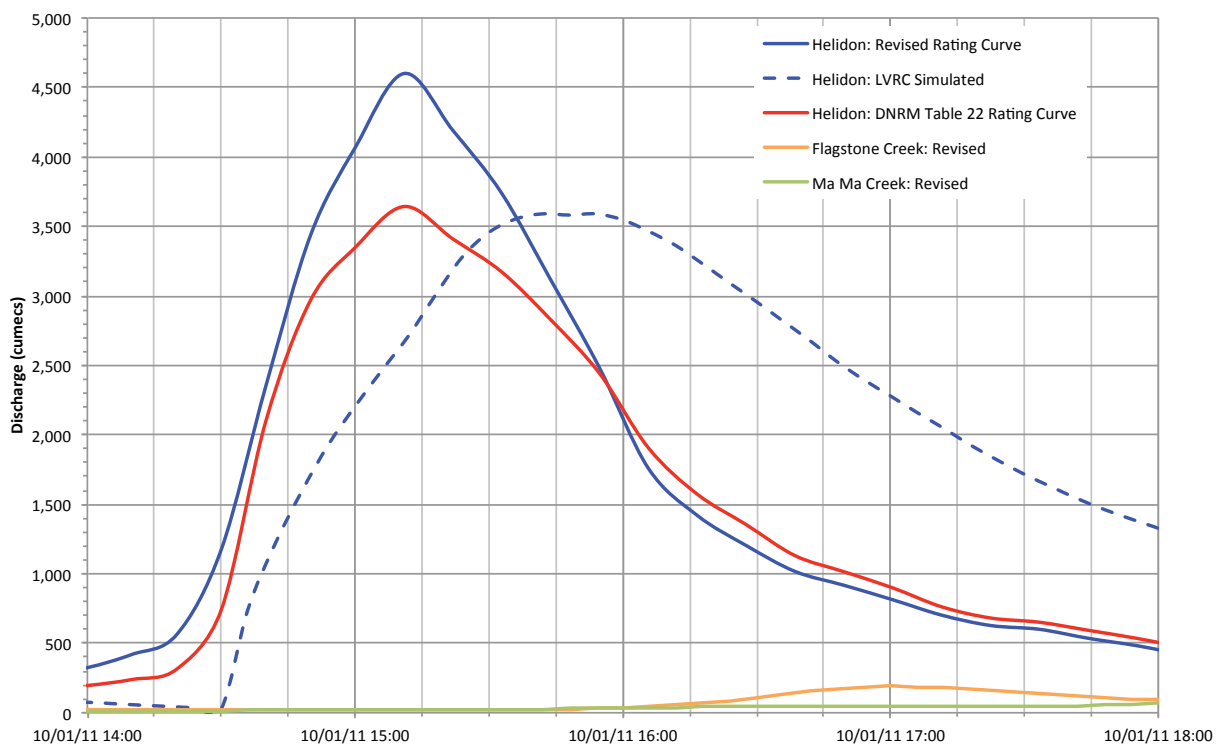
**Figure 8.7 – Revised Flood Flow Hydrographs at Helidon, Flagstone and Ma Ma Creeks**

193. The other very important characteristics of the revised hydrograph shown in Figure 8.7 are: the timing of the peak now matches the DNRM time of recorded water levels; and the shape of the hydrograph now seems to better match the original DNRM estimated hydrograph (shown as the red line in Figure 8.7).

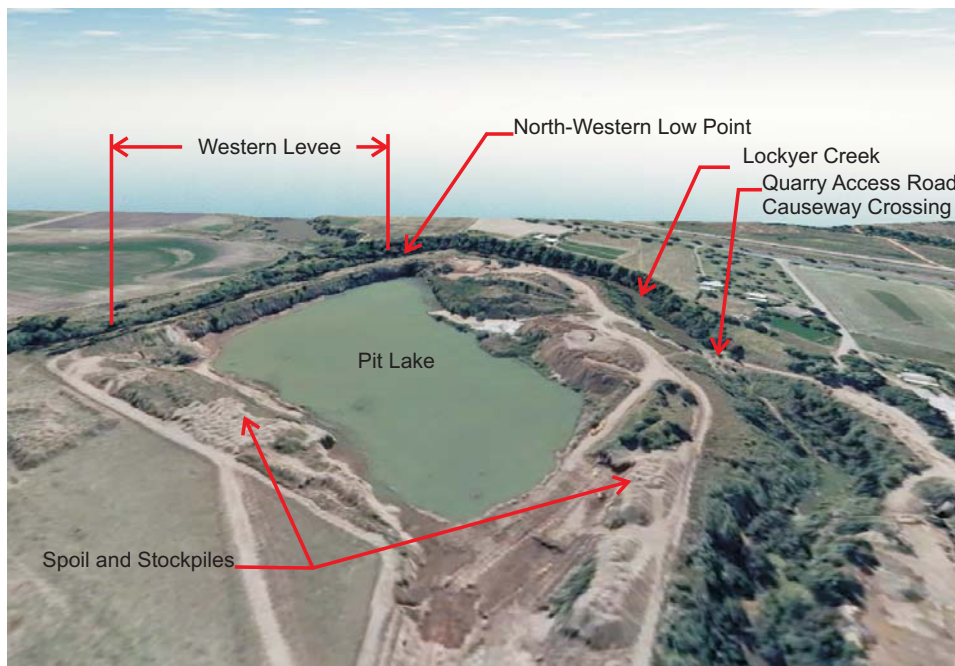
**Figure 8.12 – Oblique Showing Pre-flood Quarry as at August 2010**

200. I have also prepared an oblique image showing the Quarry as of August 2010 with annotations and labels of features, Figure 8.12.

201. My oblique image (Figure 8.12) is for conditions prior to the occurrence of the 10<sup>th</sup> January 2011 flood and shows the pit surrounded by a system of bunds, spoil and stockpiles. Although I have not been able to identify any clear record of the line and level of these levees prior to the 2011 Flood Event, I have had the benefit of the opinion of Mr Starr (Geotechnical Expert). That opinion confirms my understanding that survey data captured by LIDAR aerial survey in August 2010 provides a reasonable representation of the quarry as at 10<sup>th</sup> January 2011.

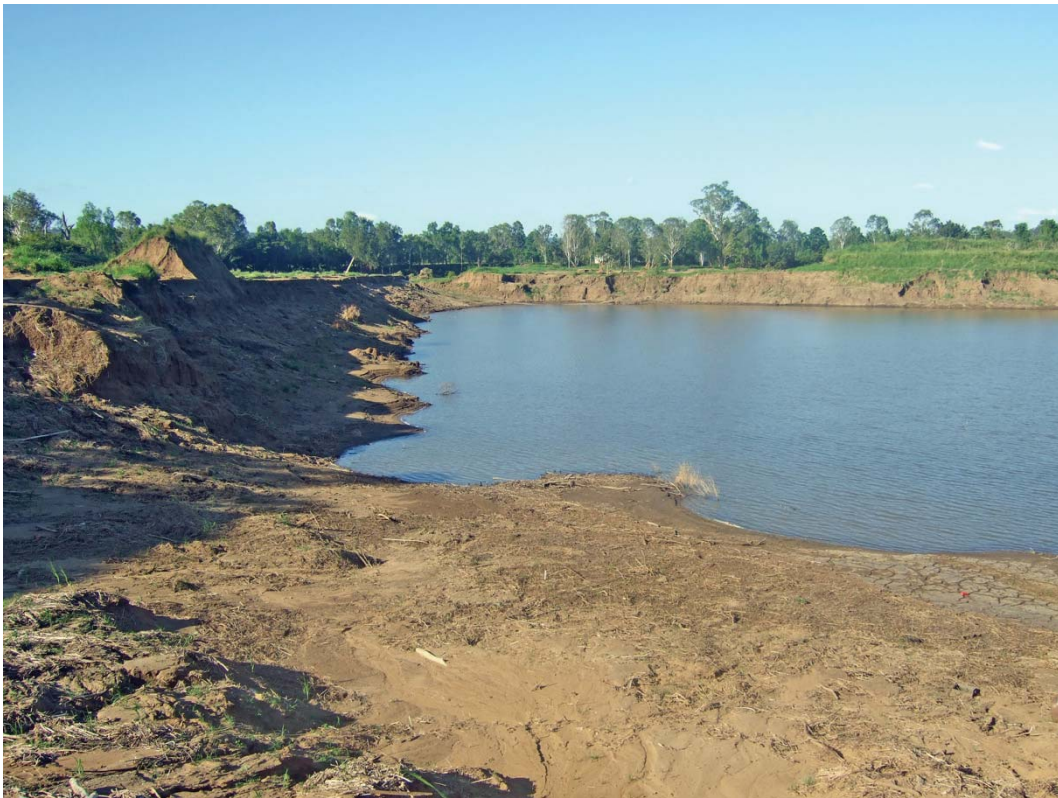
**Figure 8.14 – Inside Western Levee Looking North as at 12 February 2011 (McIntosh 2015)**

205. During my inspection of the quarry, I noted what appeared to be a relatively steep cliff face along the inside edge of the western side of the quarry pit. The nature of this face indicated to me the likelihood that a form of landslip failure had occurred at some stage during the course of the flood event. My inspection of the pre and post-flood aerial photographs indicated that the alignment of this slip face appeared to run close to the alignment of the original Eastern Bund in parts.

- erosion of the Main Breach by floodwater flowing into the pit; and
  - slip failure along portions of the eastern side of the Western Levee.
208. Whereas the process of erosion happens progressively over a period of time, albeit sometimes relatively quickly, it is not unusual for slip failures to occur relatively rapidly (i.e. in a matter of minutes). Slip failures are also usually triggered by some external influence, for example the rapid draw down of water in creeks after a flood often results in bank slumping (a form of slip failure), or the undermining of the base of a steep batter can also initiate failure. I consider that both of these example mechanisms are equally applicable to the Grantham Quarry pit. However, I consider top down erosion as the most likely because:

- the occurrence of slip failure is usually on account of loss of material strength through saturation, or on account of foundation material giving away. I consider that these conditions are unlikely to have developed prior to the bunds being overtopped by the rapidly rising floodwater in Lockyer Creek; and

- slip failures more often occur on the recession of a flood when the water recedes from a saturated bank, and in my opinion, evidence of this type of post-flood failure is seen in the photograph.

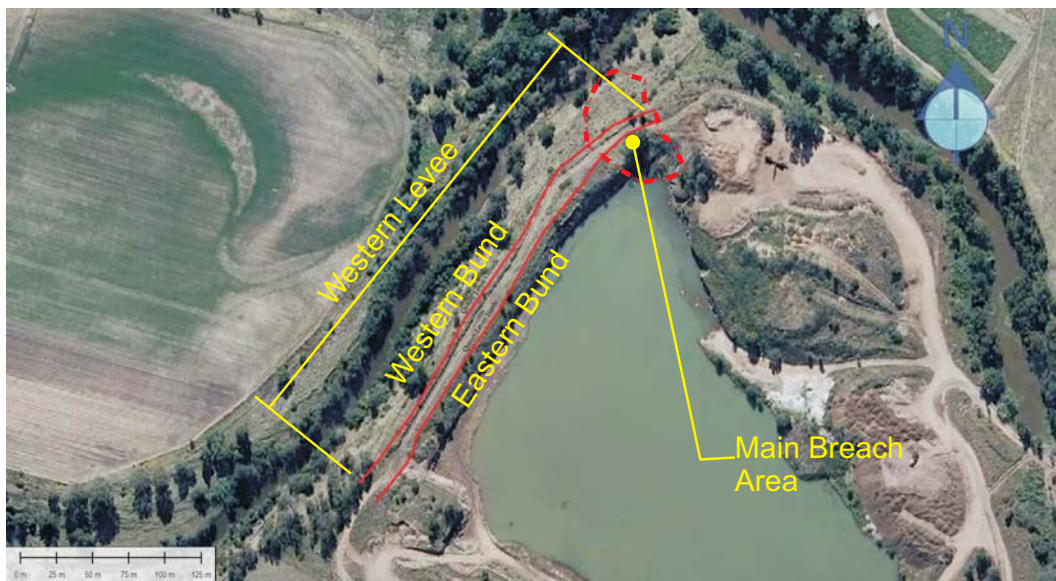
**Figure 8.15 – Alignment of Pre Flood Quarry Bunds and Location of Main Breach**

215. During the course of the flood a significant breach scoured in the low point of the Western Levee (dashed red line) as indicated in Figure 8.15. The levee also suffered significant damage as well as creek banks and the inside of the quarry wall. An aerial photograph taken a short time after the 2011 Floods is shown in Figure 8.16 with same alignment lines marked.

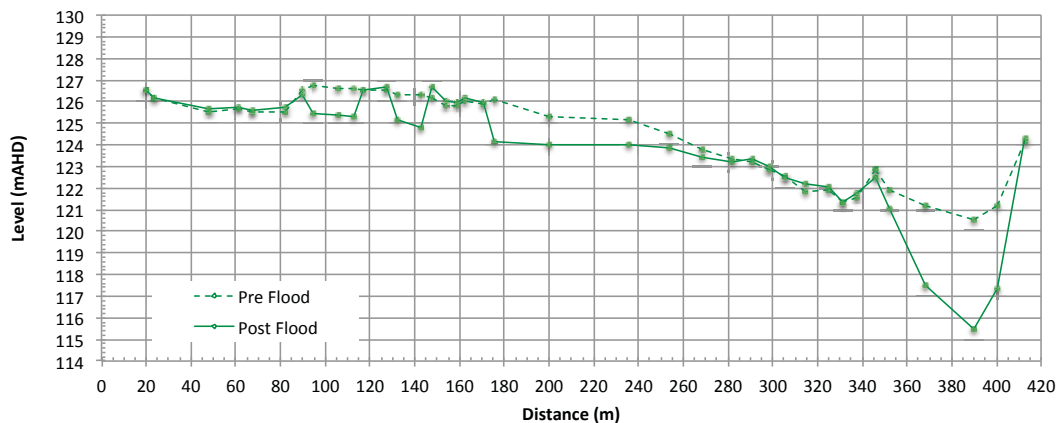
216. I have extracted longitudinal profiles along the alignment of these bunds for both pre and post flood conditions from LIDAR data captured with the aerial photographs. These are plotted in Figure 8.17 and 8.18 for the Eastern and Western Bunds respectively.

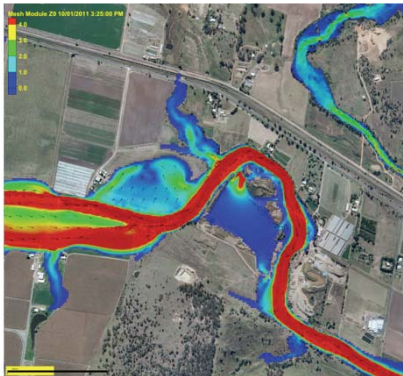
<p>(e) 3:25pm</p> <ul style="list-style-type: none"> <li>• Lockyer Creek has broken out upstream from the quarry.</li> <li>• "Oval" area upstream of quarry receiving inflow.</li> </ul>

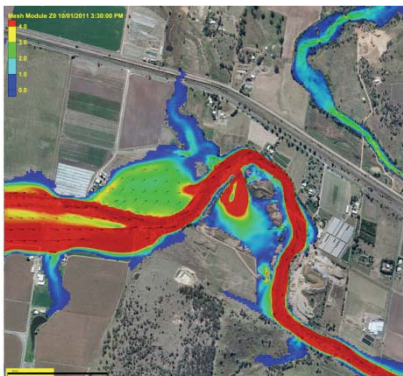
<p>(f) 3:30pm</p> <ul style="list-style-type: none"> <li>• A marked increase in intensity of spill into the quarry associated with further erosion of the Main Breach.</li> <li>• Flow depths and intensities upstream from quarry continue to increase.</li> <li>• The Main Breach in the Western Levee has initiated.</li> </ul>

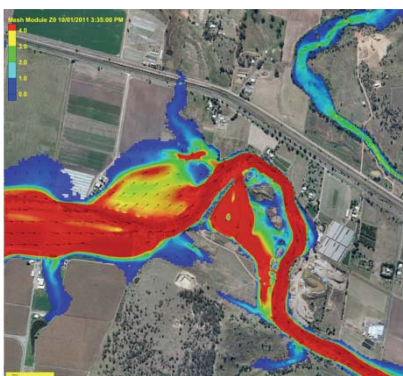
<p>(g) 3:35pm</p> <ul style="list-style-type: none"> <li>• Commencement of outflow from the quarry through the south-eastern quadrant.</li> <li>• Breakout from Lockyer Creek at Quarry Access Road causeway commences with a rapid rise in local water levels.</li> <li>• Flow depths and intensities upstream from the quarry continue to increase.</li> </ul>

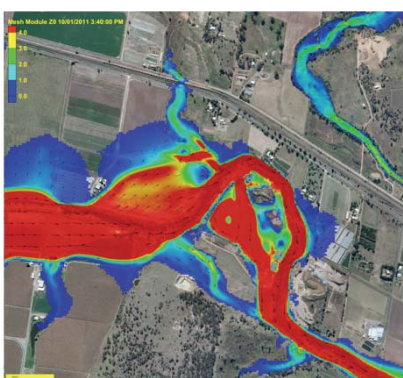
<p>(h) 3:40</p> <ul style="list-style-type: none"> <li>• Failure of Main Breach complete.</li> <li>• Breakout from Lockyer Creek at Quarry Access Road causeway continues with a rapid rise in local water levels.</li> <li>• Full breaking out of the right overbank flow path to the south of the quarry.</li> <li>• Flow depths and intensities upstream from the quarry continue to increase.</li> </ul>

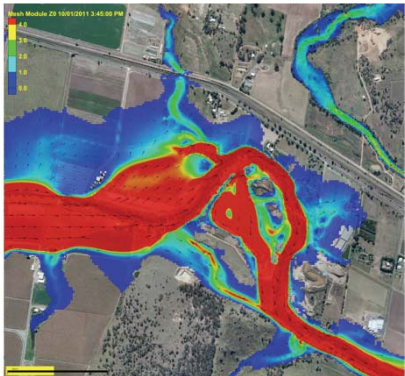
<p>(i) 3:45pm</p> <ul style="list-style-type: none"> <li>• Breakout from Lockyer Creek at Quarry Access Road causeway continues with a rapid rise in local water levels.</li> <li>• Flow intensities starting to increase at the Quarry Access Road causeway breakout.</li> <li>• Full breaking out of the right overbank flow path to the south of the quarry.</li> <li>• Flow depths and intensities continue to increase throughout</li> </ul>

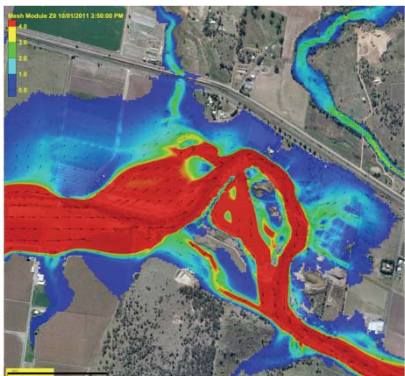
<p>(j) 3:50pm</p> <ul style="list-style-type: none"> <li>• Initiation of erosion of the bunds in the Western Levee (other than in the area of the Main Breach).</li> <li>• Depth of water at 1615 Gatton-Helidon Road exceeds 0.3m (my estimated time of closure for evacuation purposes).</li> <li>• Flows commence along the Western Overbank flow path.</li> </ul>

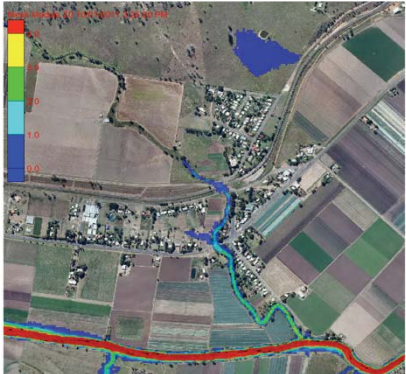
<p>(a) 3:25pm</p> <ul style="list-style-type: none"> <li>Sandy Creek has just surcharged and commenced inundating Central Grantham.</li> </ul>

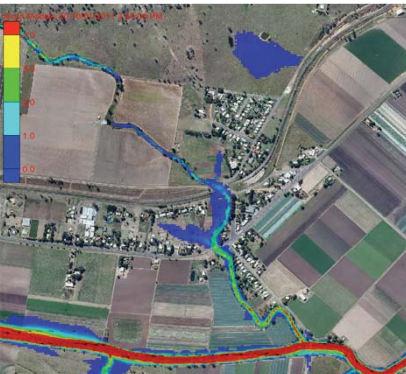
<p>(b) 3:40pm</p> <ul style="list-style-type: none"> <li>Sandy Creek surcharge continues inundating Central Grantham.</li> <li>Note that erosion of the Main Breach at the quarry has already been initiated.</li> </ul>

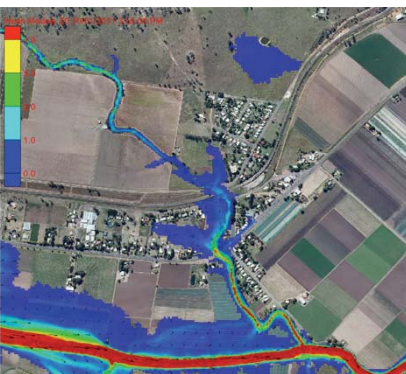
<p>(c) 3:55pm</p> <ul style="list-style-type: none"> <li>Lockyer Creek has broken its banks with inundating flows rapidly approaching Grantham from the South-Western Overbank flow path.</li> <li>The Gattton-Helidon bridge over Sandy Creek has now been overtopped and within 1 minute the depth will exceed 0.3m (my estimated time of closure for evacuation purposes). This will result in closure of the last evacuation route for Western Grantham.</li> <li>Note that erosion of the Main Breach has completed.</li> <li>Note that erosion of the bunds in the Western Levee (other than in the area of the Main Breach) have commenced.</li> </ul>

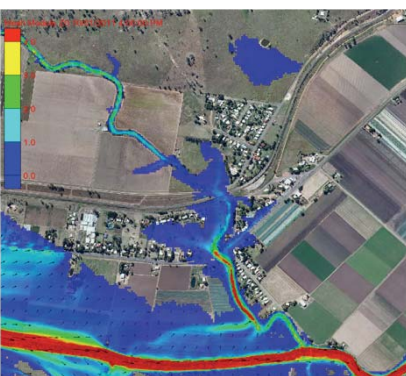
<p>(d) 4:00pm</p> <ul style="list-style-type: none"> <li>Floodwater from Lockyer Creek over the South-Western Overbank flow path has overtopped the Gattton-Helidon Road in Western Grantham, but these floodwaters have not yet reached the road within Central Grantham.</li> <li>Sandy Creek surcharge is continuing to inundate Central Grantham, but not as quickly as it is occurring in Western Grantham.</li> </ul>

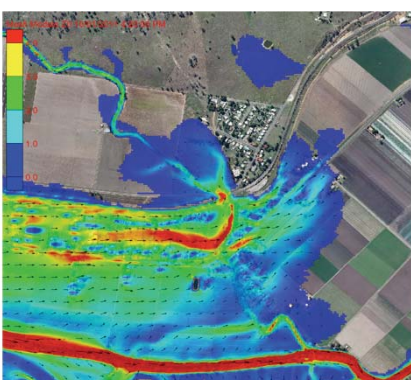
<p>(h) 4:20</p> <ul style="list-style-type: none"> <li>Floodwater has commenced overtopping the railway embankment.</li> <li>Flood inflows under the rail bridge continue to intensify as the fast moving floodwater from the South-Western Overbank flows combine with those from the Western Overbank flows.</li> <li>Flow intensities have increased in Eastern Grantham.</li> </ul>

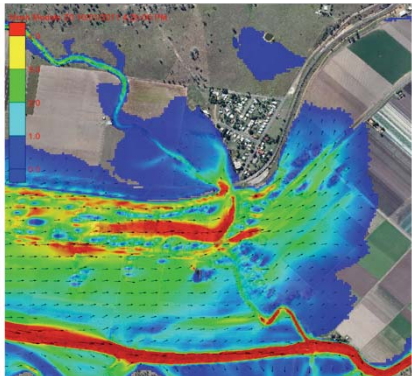
<p>(i) 4:25pm</p> <ul style="list-style-type: none"> <li>• Floodwater continues to overtop the railway embankment.</li> <li>• Inflows under the rail bridge continue at high intensity.</li> <li>• Flow intensities have increased in Eastern Grantham.</li> </ul>

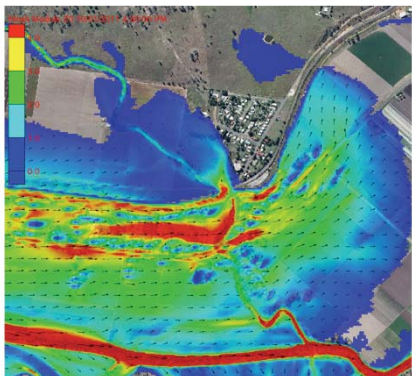
<p>(j) 4:30pm</p> <ul style="list-style-type: none"> <li>• Floodwater continues to overtop the railway embankment.</li> <li>• Inflows under the rail bridge continue at high intensity.</li> <li>• Flow intensities continue to increase within Eastern Grantham.</li> </ul>

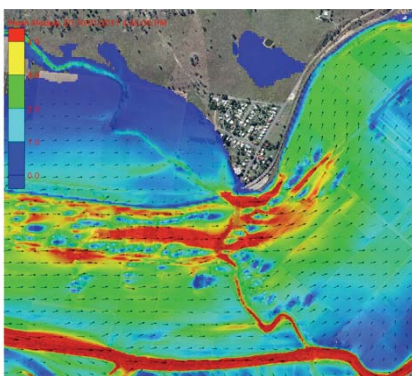
<p>(k) 4:45pm</p> <ul style="list-style-type: none"> <li>• Flows at the rail bridge location reverse in consequence of rail embankment overflows.</li> <li>• Flow intensities in Eastern Grantham significantly increase in conjunction with the rail bridge flow reversal.</li> <li>• Flood flow intensities in Central and Eastern Grantham around their peak.</li> </ul>

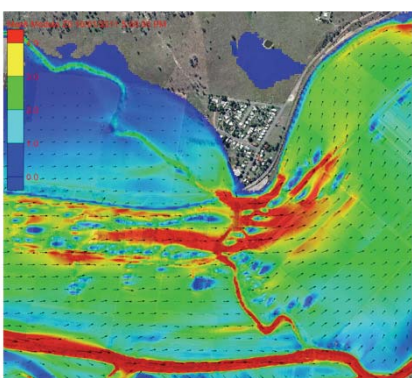
<p>(l) 5:00pm</p> <ul style="list-style-type: none"> <li>• Flood flow intensities in Central and Eastern Grantham around their peak.</li> </ul>

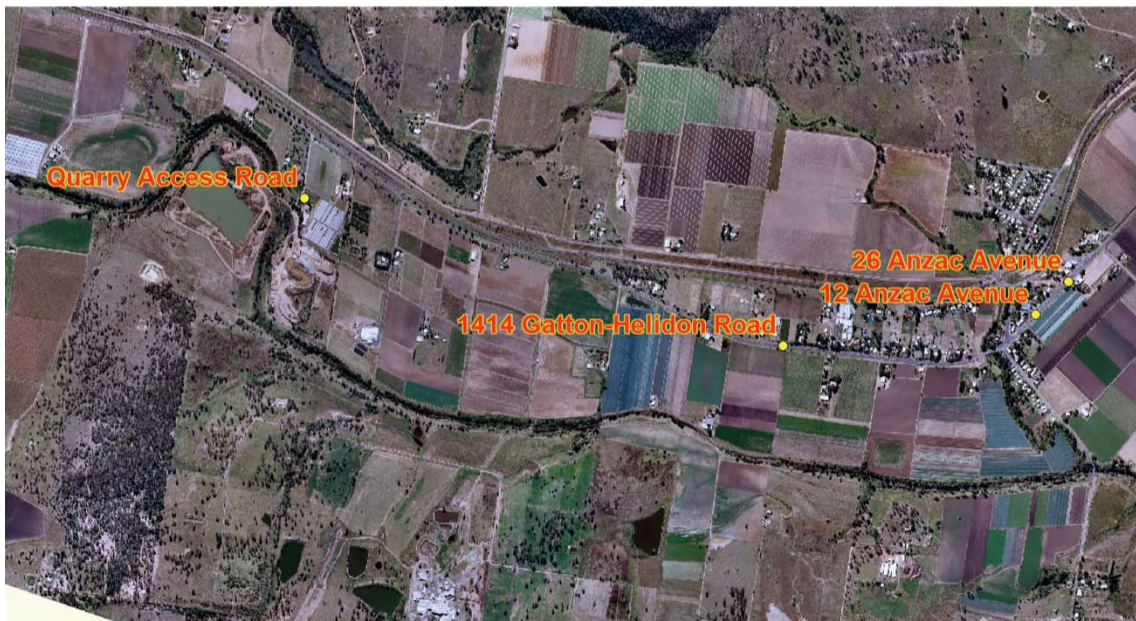
**Figure 10.5 – Flow Depth and Intensity Hydrograph Locations**

332. I have selected the flow hydrograph reporting locations indicated in Figure 10.5 because they give representative coverage of depth and flow intensity measurements within and around Grantham. Depth and flow intensity measurements are good indicators for the quantification of flood hazard.

384. I have also examined how the Worst Case scenarios would affect flood hazard by extracting flow depth and intensity hydrographs at the selected sampling locations marked in Figure 10.5. These are plotted in Figure 10.18 (larger copies of these graphs are replicated in Appendix C).

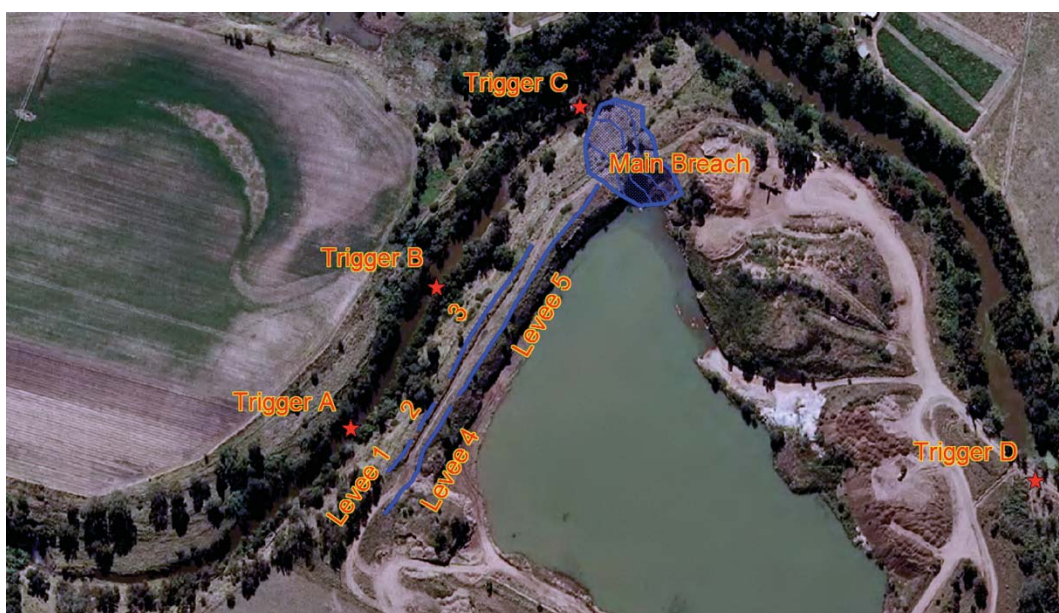
**Figure 10.9 – Quarry Failure Trigger Level Locations**

344. For the purposes of this assessment I have assumed that both the Eastern and Western Bunds, and Main Breach develop to their post-flood extent over the erosion time. I have also assumed that the erosion of the Eastern and Western Bunds, and Main Breach is triggered at three points (A, B, C) as indicated in Figure 10.9 below. I have associated these triggers to individual bunds (shown as Levee 1 to 5) also shown in Figure 10.9. When flood levels reach the same height as that of a trigger it will cause the start of simulated erosion of the associated bund. For example, when the water level reaches the trigger level for location C simulated erosion will then commence at the Main Breach. I have provided in Appendix B.6 a table that specifies the flood level for each trigger location and the corresponding time of trigger. Due to the difference in heights at locations A, B and C triggering will occur at different times and bund erosion will occur progressively.

345. The trigger heights have also been set so as not to trigger until the levees as depicted in Figure 10.9 above have been overtopped. I have done this in consideration of the rapid rate of rise of the flow hydrograph, which I consider would most likely result in the occurrence of a top down erosion breach of the Western Levee.
346. The relevant flood levels that trigger the Main Breach and the remainder of the Eastern and Western Bunds are broadly:
- Main Breach: 125.0mAHD
  - Eastern and Western Bunds: 127.6mAHD
347. Applying the trigger mechanism described above to the GFCOI model produces failure initiation times. I have extracted these times from simulation outcomes as well as the status of flood levels in Lockyer Creek and the pit lake at the same time. This information is listed in Table 10.1.

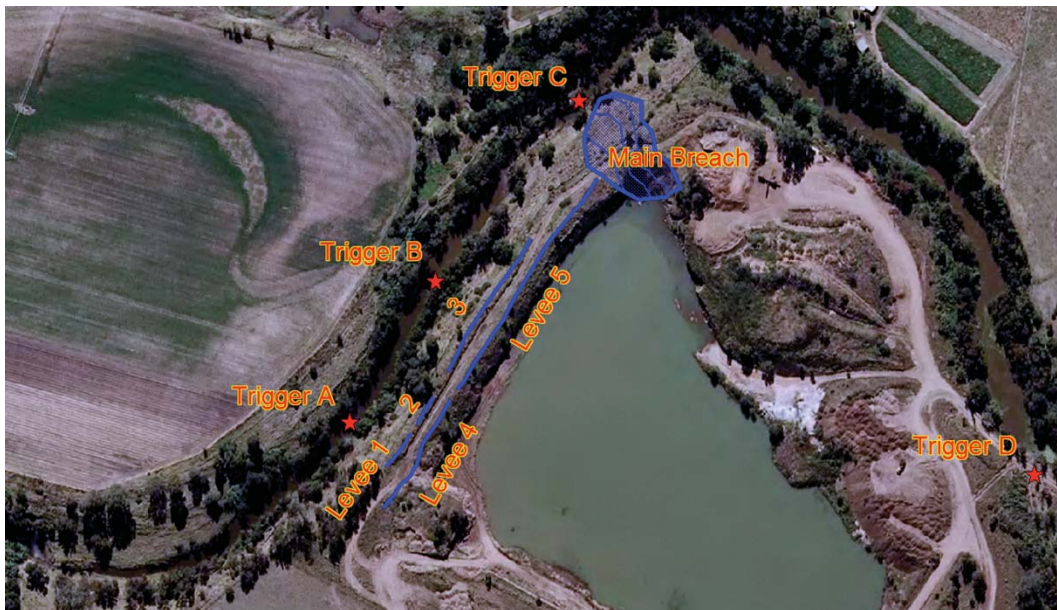
**Figure 10.13 – Quarry Failure Trigger Level Locations**

359. I have configured initiation of levee failure using the simulated water level in Lockyer Creek at the location marked Trigger D in Figure 10.13 below. Also, I have used the location marked Trigger B for water level reporting purposes (not to be confused with Trigger D).

361. I have extracted the simulated times of levee failure triggering, and the associated water levels in Lockyer Creek to the west of the levees (I have used the location marked as Trigger B, Figure 10.13 for reporting water level), from the GFCOI model for the trigger level scenario cases shown in Figure 10.13, as listed in Table 10.2.
