14 Flood Evacuation

**GRANTHAM FLOODS COMMISSION OF INQUIRY
EXPERT HYDROLOGY REPORT 10 JANUARY 2011 FLOOD
CIRCUMSTANCES AND CONTRIBUTING FACTORS**

Appendix B – Technical Reviews

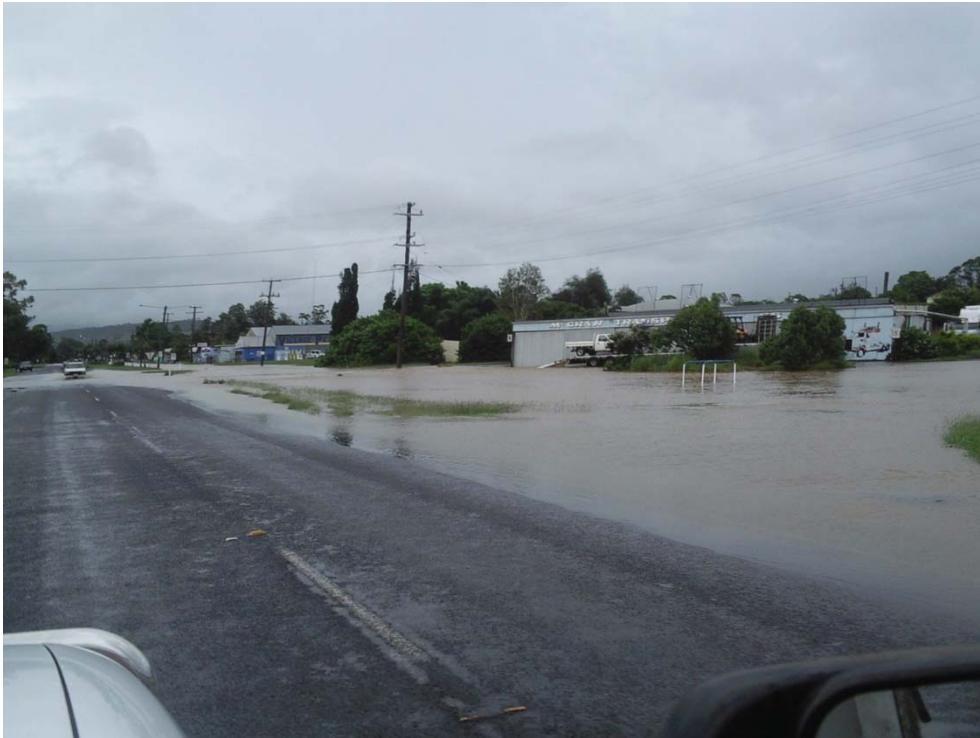
Figure 14.2 – Photograph of Gatton-Helidon Road near Armstrong Road, approaching Anzac Avenue at 3:53pm

- at 3:53pm, the Gatton-Helidon Road near Armstrong Road, approaching Anzac Avenue was not inundated (Photo 0316), consistent with Most Likely simulation outcomes. A copy of Photo 0316 is shown in Figure 14.2 below;

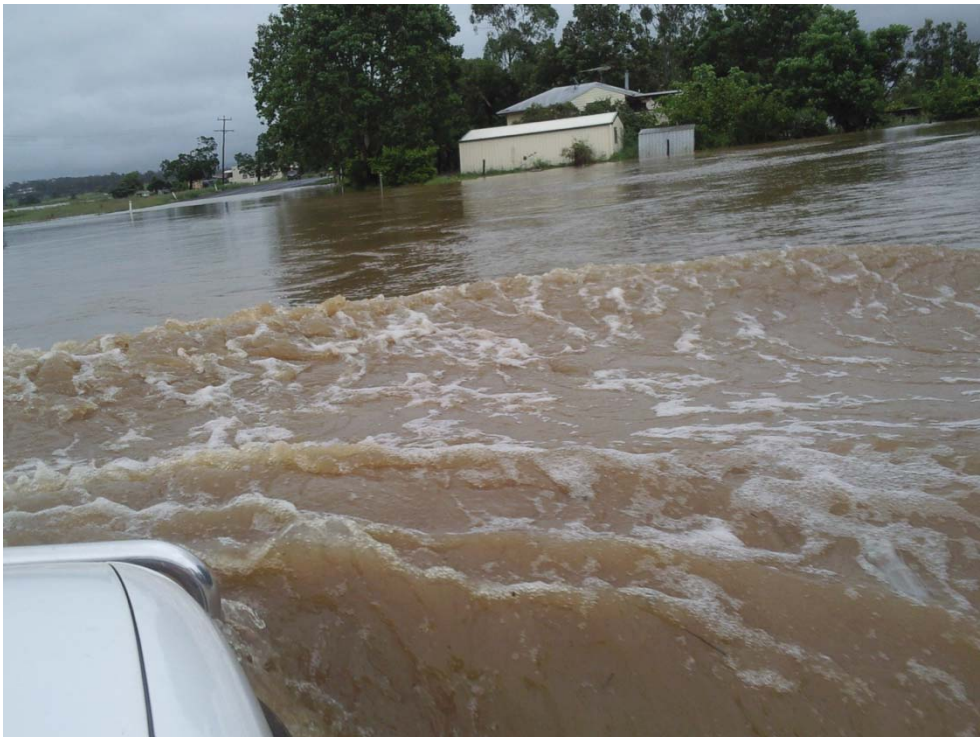
Figure 14.3 – Photograph of Gatton-Helidon Road bridge crossing of Sandy Creek at 3:56pm

- at 3:56pm, the Gatton-Helidon Road bridge crossing of Sandy Creek had flooded over the road (Photo 0319), consistent with Most Likely simulation outcomes. A copy of Photo 0319 is shown in Figure 14.3 below;

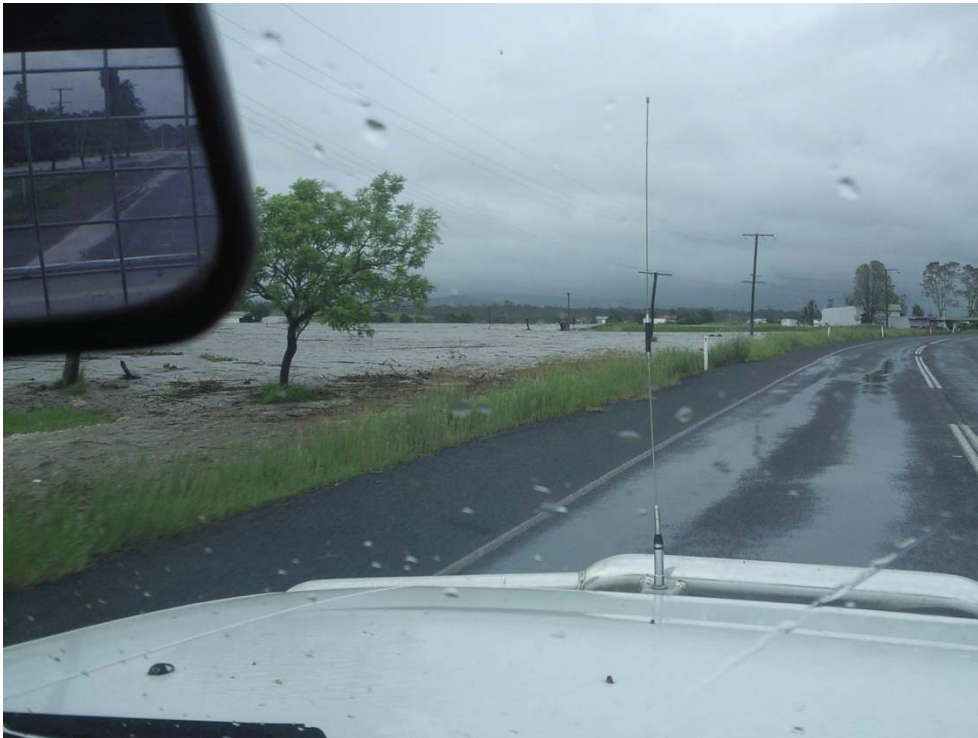
Figure 14.4 – Photograph of Gatton-Helidon Road past Citrus and approaching Sorrensen Street at 3:58pm

- at 3:58pm, the Gatton-Helidon Road past Citrus and approaching Sorrensen Street, Photo 0320 shows that floodwater inundation was up high against the southern side of the road (I am unable to discern the height of the water from the photograph), consistent with Most Likely simulation outcomes. A copy of Photo 0320 is shown in Figure 14.4 below;

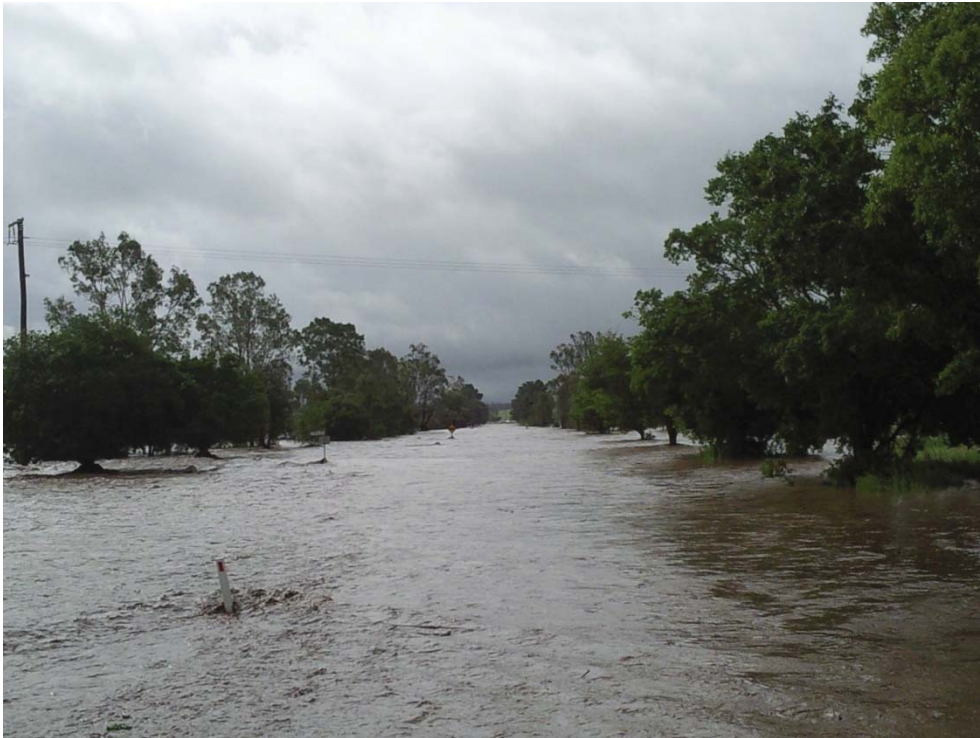
**Figure 14.5 – Photograph of Gattton-Helidon Road near the intersection of Dorrs Road at
4:10pm**

- at 4:10pm, the Gatton-Helidon Road near the intersection of Dorrs Road (Photo 0323) has been completely inundated, once again consistent with Most Likely simulation outcomes. A copy of Photo 0320 is shown in Figure 14.5 on the following page;
427. Mr Steffens' observations are consistent with my assessment of the sequence of time of road closure along the Gatton-Helidon Road (depth greater than 0.3m):
- first, Sandy Creek Bridge (simulated at 3:56pm);
 - second, near 1615 Gatton-Helidon Road just west of Dorrs road (simulated at 3:50pm); and
 - third, near 1439 Gatton-Helidon Road near Sorrensen Street (simulated at 4:00pm).

That is, Mr Steffens drove across the flooded Sandy Creek Bridge, and past Sorrensen Street, but was then unable to proceed past Dorrs Road.

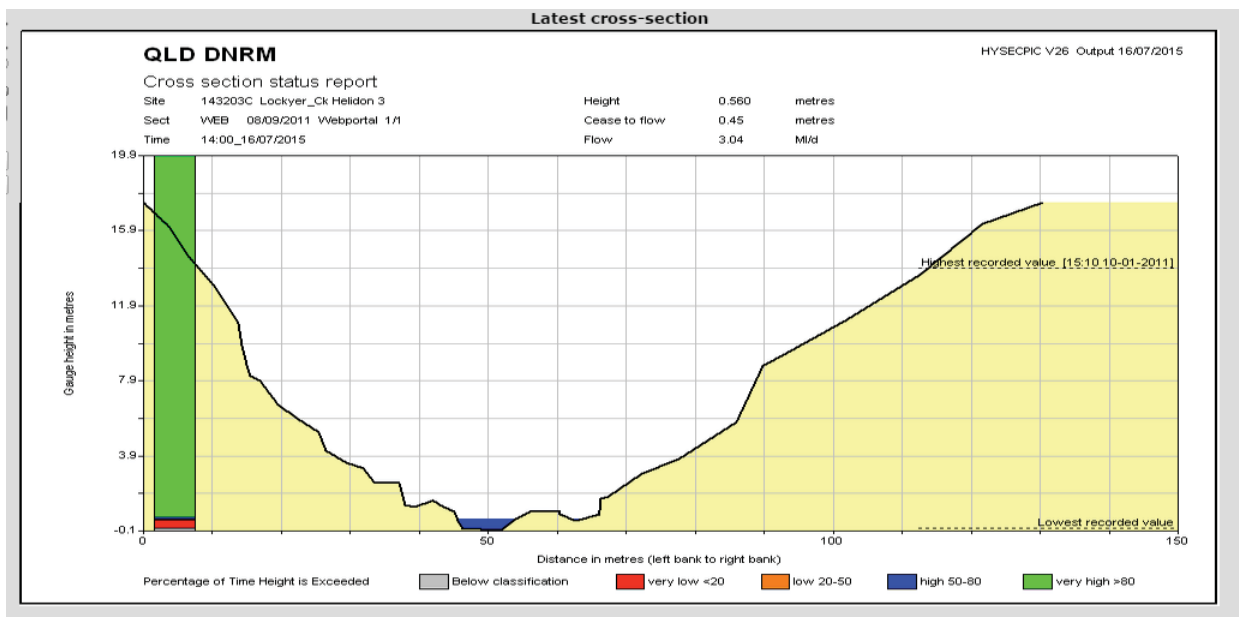
Figure B.1 – Helidon Gauging Station: Site Cross-section (DNRM Water Monitoring Portal)

- A rating curve is used to convert recorded heights to estimated flow rates. DNRM hydrographers develop the DNRM rating curve based on the cross-section at the gauge and measured flow velocities across the cross-section during flow events (referred to as gaugings). The latest DNRM cross-section for the site is shown Figure B.1 and the DNRM rating curve and gaugings on Figure B.2.

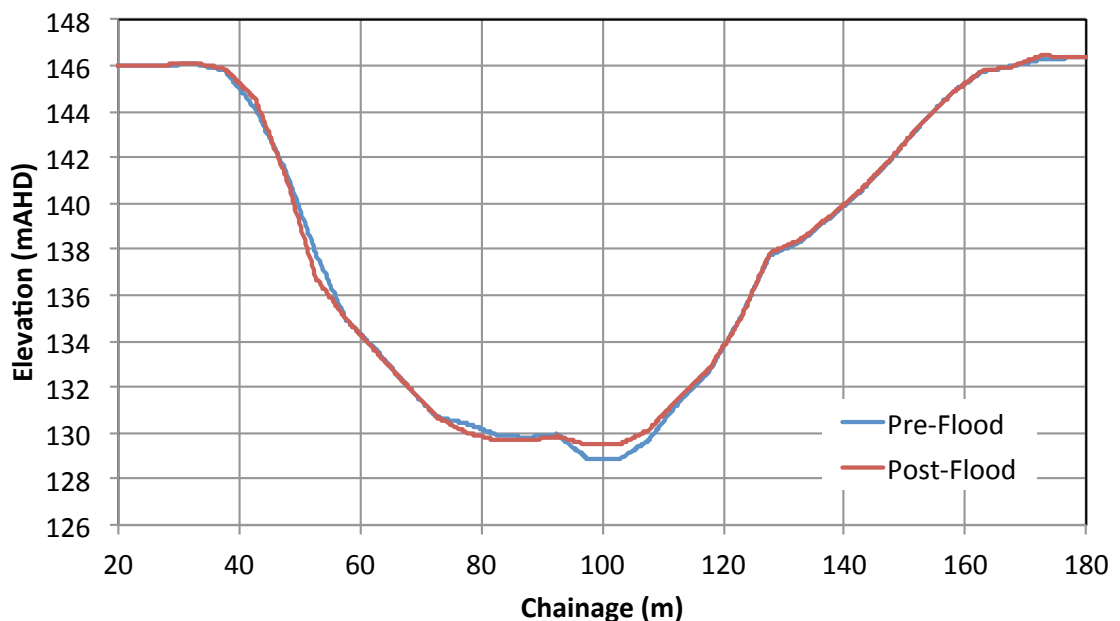
Figure B.3 – Helidon Gauging Station: Comparison of Pre and Post Flood LIDAR Cross-Sections

9. Cross-sections for the Gauging Station 143203C site were extracted from LIDAR data taken before and after the 2011 flood. A plot of the two cross-sections is shown in the figure below.

10. I note from the aerial photographs (2011) that there was ponded water in the cross-section in the post flood survey, and LIDAR does not typically penetrate ponded water. The cross-sections shown above are only considered valid above the ponded water level (about EL 129.5m AHD).
11. As can be seen in Figure B.3 the change in the area available for large flows (peak of the 2011 flood about 142.5m AHD) is minimal. The cross-sectional area at the peak of 2011 flood is

estimated to be approximately 880m² (above EL 129.5m AHD) pre flood, compared to 885m² post flood, a difference of approximately 0.5%.

12. This small change is likely to affect the high stage-rating curve in a linear manner, e.g. the 0.5% increase in area means that flow may increase at a particular EL by about 0.5%.
13. As this difference is relatively small, it is concluded that the change in cross-section at the Gauging Station143203C site has minimal impact on the rating curve for the site.

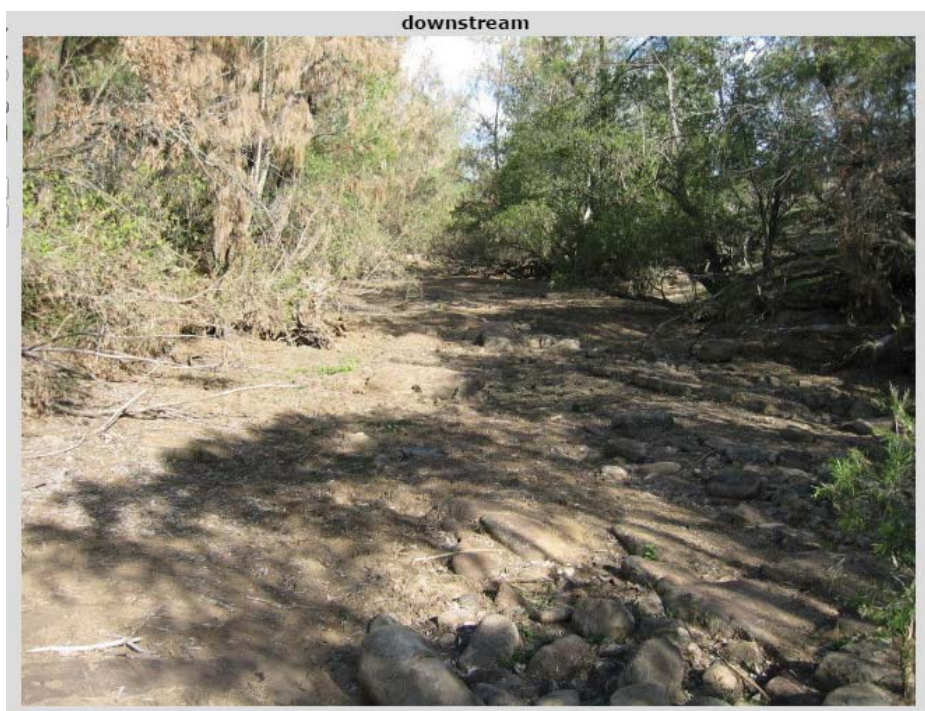
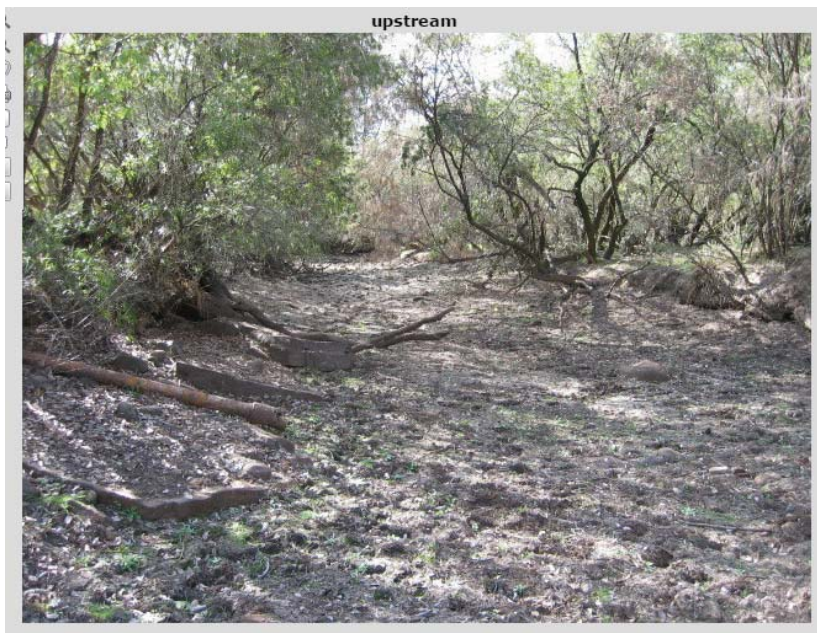
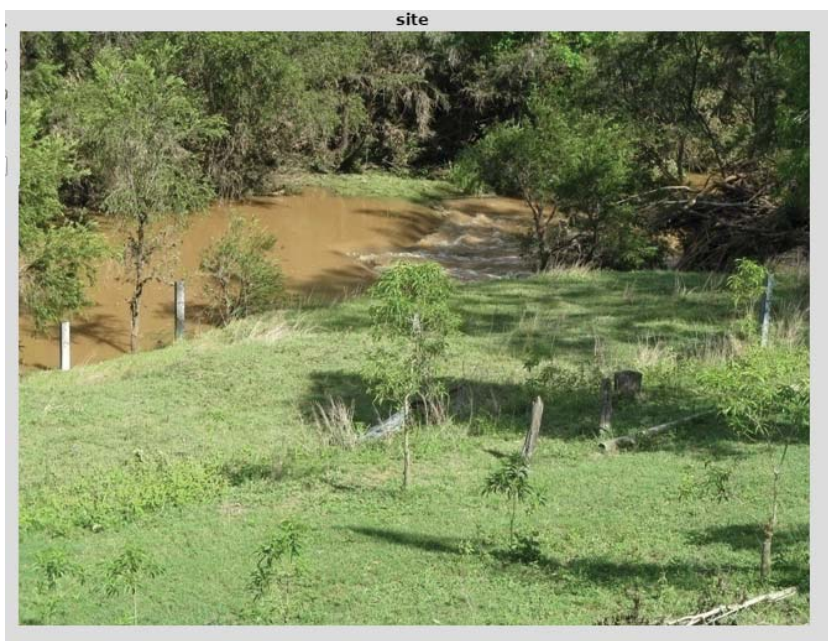
14. The Manning's n roughness used in the modelling of flood flows for a site is typically initially based on the bed material and vegetation observed in a site inspection or from review of site photographs. A range of guidelines (such as Chow 1959) provides a table of typical roughness values for various stream and vegetation conditions.
15. If calibration data is available, roughness is typically a key calibration parameter, with the values used adjusted within reasonable ranges to provide a close match to observed flood behaviour.
16. Photographs of the site, from the DNRM Water Monitoring Portal, are provided in Figure B.4 to Figure B.6 and aerial photography of the site pre/post event in Figure B.7.

Figure B.4 – Helidon Gauging Station: View Downstream (DNRM Water Monitoring Portal)

Figure B.5 – Helidon Gauging Station: View Upstream (DNRM Water Monitoring Portal)

Figure B.6 – Helidon Gauging Station: View of Site (DNRM Water Monitoring Portal)

17. Based on these photographs:
 - The central channel is reasonably clear with a gravel/cobbles bed.
 - Dense vegetation is present on the low banks
 - the right bank above the low bank is largely cleared, and grass appears grazed/short.
 - Higher up the left bank has some light to medium forest cover.
18. The average cross-sectional roughness for these conditions for large floods is estimated to be in the range 0.035 to 0.08.
19. Post-flood, much of the vegetation has been removed, although the canopy of the fallen trees still provides some impedance to flows. Roughness post-flood is estimated in the range 0.03 to 0.06.
20. An estimated roughness was back-calculated from the DNRM rating curve using the Manning's equation. A flood slope of 0.035 was adopted, based on the local flood slope measured from

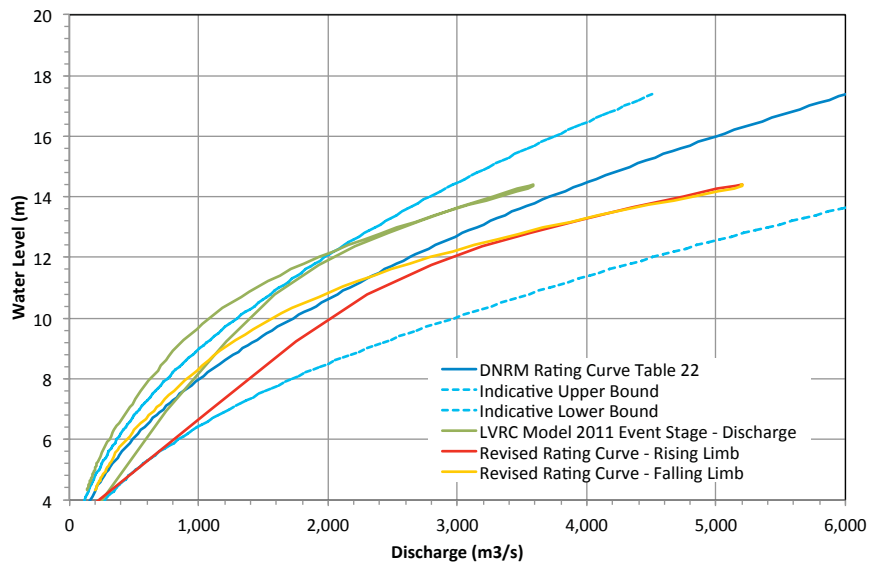
Figure B.11 – Helidon (143203C): Revised Rating Curve for 2011 flood

6. The same scaling factor was applied to the LVRC falling limb hydrograph.
31. The revised rising limb and falling limb rating curves developed from the above technique, for application to the recorded levels for the 2011 flood at Helidon, are presented in Figure B.11 below.

27. Figure B.11 provides a range of rating curve for various assumed roughness, and it is considered that this range provides a reasonable appreciation of the accuracy of the rating curve at high

- stage. At the peak of the 2011 flood (142.5m AHD) Figure B.11 indicates that the equivalent flow may be between 2,600 and 6,000m³/s.
28. Based on the above, it is considered likely that the errors in the high stage rating curve has led to excessive routing being included in the LVRC models in order to match the peak flow rate from the DNRM Rating Curve.

32. Figure B.11 shows some indicative bounds on the DNRM Rating Curve. These indicative bounds were determined based on adjusting the DNRM Rating Curve by the range of Manning’s n values examined in Section B.2. The plot shows the revised rating curves falls within these reasonable bounds.
33. It was concluded that the revised rising and falling limb rating curves are reasonable, and thus they were applied to the recorded levels at the Helidon Gauging Station. The resultant hydrographs are plotted in the figure below.

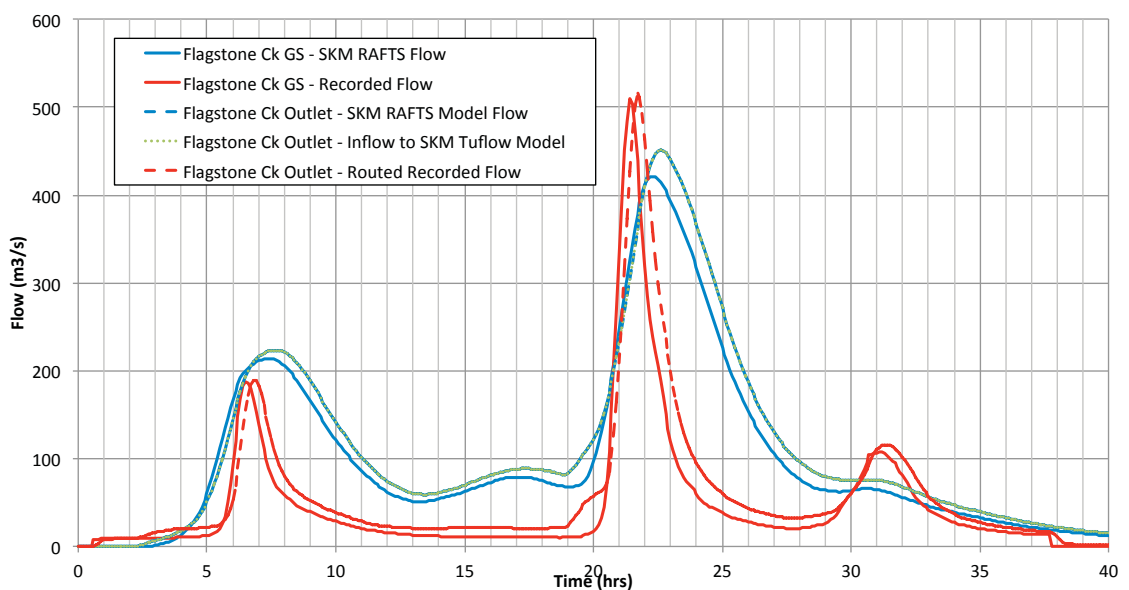
Figure B.13 – Flagstone Creek Revised Hydrology

38. A plot of the changes to the inflow files are provided below in Figures B.13 and B.14.

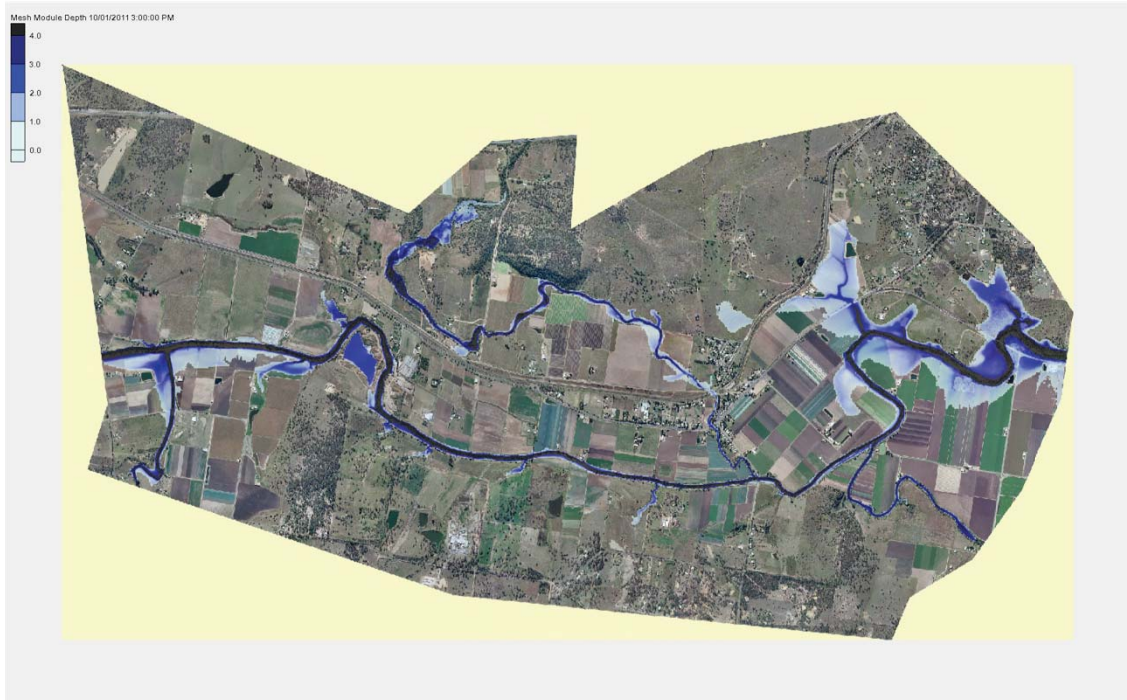
Figure B.16 – Initial Flood Flow Inundation using LVRC ULG Downstream Rating

45. Simulation results obtained using the same model as used to produce Figure B.16 (following page), but with the revised rating curve (LVRC model) are presented in Figure B.17 (following page). It is seen that inundation of the floodplain areas about the downstream end of the model is no longer apparent, as expected since there is no flow in the downstream creek at 3:00pm being the time shown.

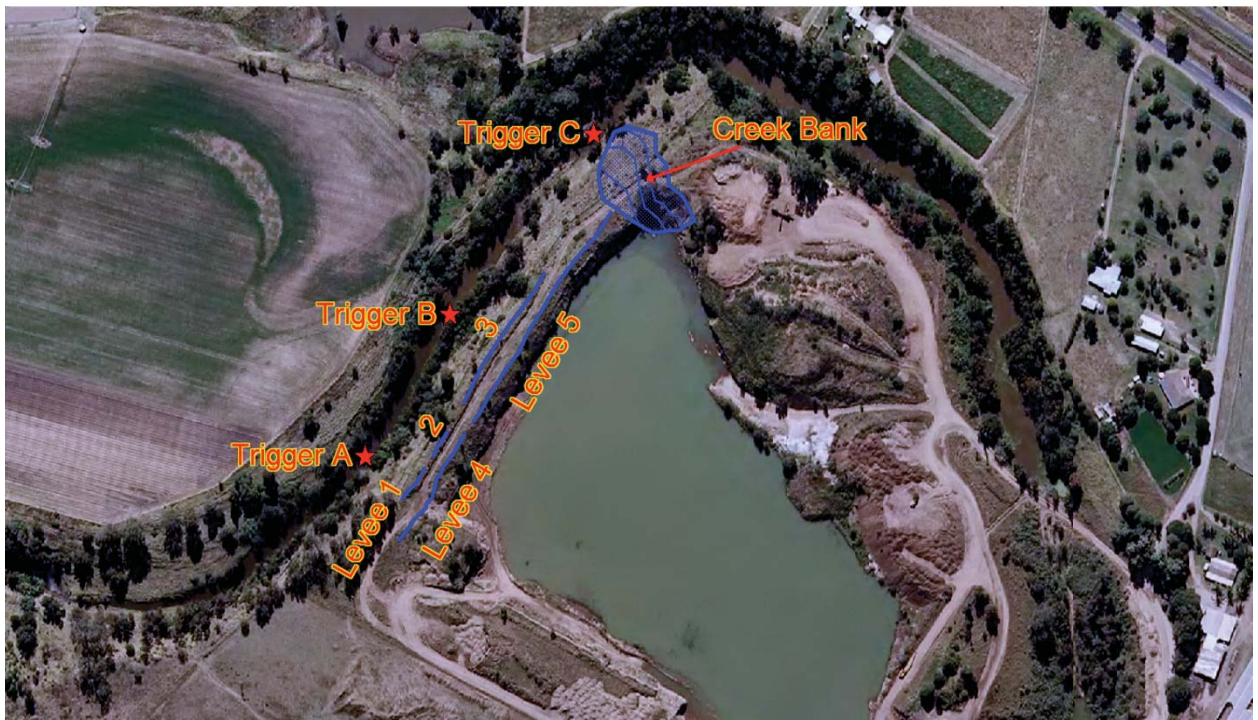
Figure B.18 – Western Levee and Main Breach Arrangement

46. I have presented details of the definition of the eroded Western Levee and Main Breach in Section 8.6. In the GFCOI model, these items have been defined by five discrete areas where the ground surface levels are set to vary from pre flood to post flood levels over a defined period of time (10 minutes in the base model). Each of these five erosion areas has also been assigned a “trigger” to signal the flood level when simulation of the erosion process should commence. The arrangement of the modelled erosion areas and associated trigger positions is shown in Figure B.18.

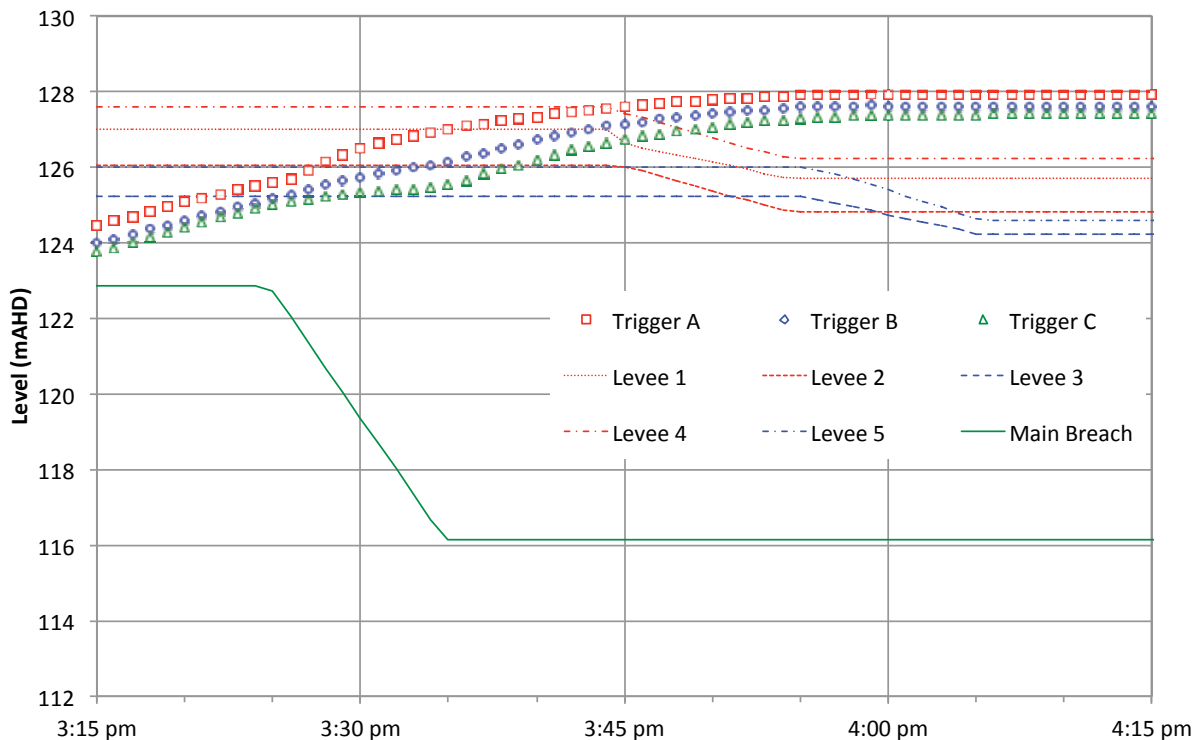
Figure B.19 – Water Surface Levels, Western Levee and Main Breach Erosion Development

48. Correct simulation of erosion and creek bank occurrence was checked by extracting time-series plots of trigger location flood level and selected spot heights on the levee embankments from simulation results. These are plotted in Figure B.19 and confirm correct simulation according to intention.

49. Review of the information also shows, for the initiation parameters used, breach erosion initiating at 3:25pm and levee erosion initiating between around 3:45pm and 3:56pm. All erosion mechanisms are seen to be completed 4:06pm (that is, 10 minutes after the last trigger).
50. It is also interesting to note that the formation of the breach appears to impact on Lockyer Creek flood levels at the Trigger C location where the levels are seen to remain almost constant over the period 3:25pm to 3:35pm, whereas levels at the other trigger locations continue to rise.
