SUBMISSION

GRANTHAM FLOODS COMMISSION OF INQUIRY

Amanda Gearing

30 June 2014, Brisbane

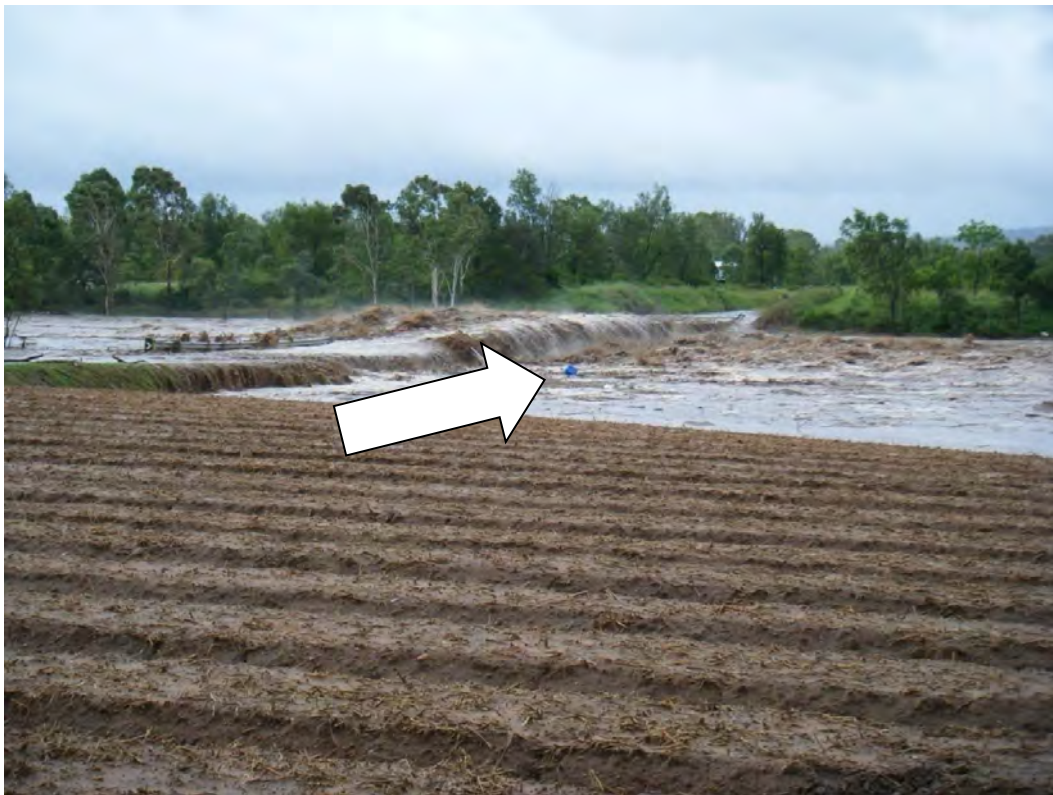
I looked again at the long series of photos I had of the flood at Kapernick's Bridge. In addition to looking at the water height, I now looked at the amount of floating debris that did not move despite the huge amount of water coming over the bridge for 80 minutes as timed by the photo series. A bright blue barrel and a bright yellow barrel remained in the series of photographs, not moving down the creek. The flood water was rising fast but not moving down the catchment.

Figure 0.3. Not moving. Blue barrel stationery in Lockyer Creek.

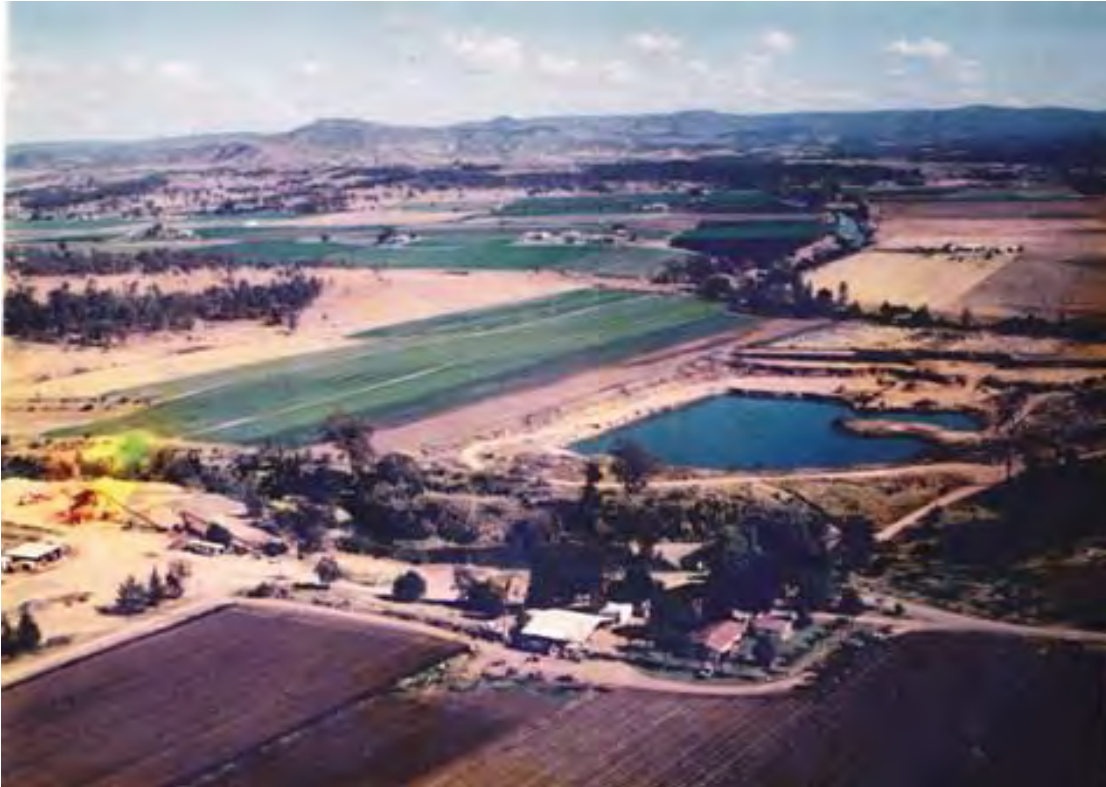
Figure 0.2. Original quarry landscape. Note the absence of any embankments on the west side of the quarry.

The quarry was mined for sand, gravel and loam by CSR (George 2015). A former employee of the quarry, Harold George said that when the sand, gravel and loam was mined, no material was placed above natural ground level due to the area being in a riparian zone. Mr George attended the quarry site on May 31, 2015 and walked around the quarry pit. He observed that the landscape had changed significantly since he had worked there. He noticed large amounts of soil had been added to the edges around the quarry pit which appeared to be 4.5metres to 6m in height (George 2015). Mr George said any claim that the embankments are ‘natural ground’ are not true, since they were not there when he worked there.

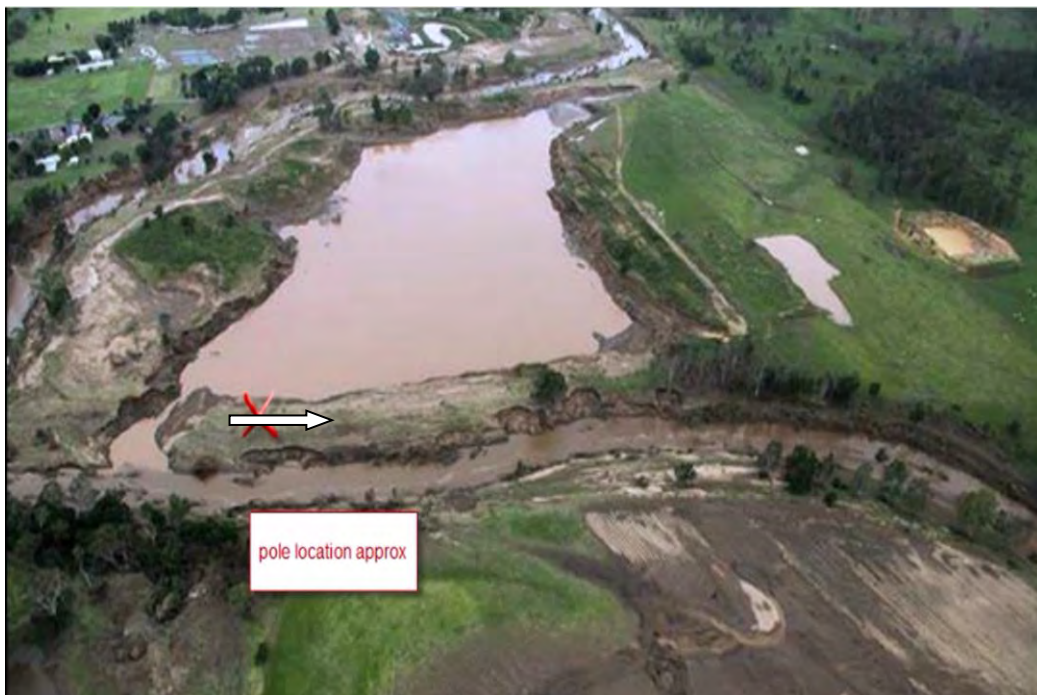
Figure 0.3. Aerial photograph of the quarry soon after the flood.

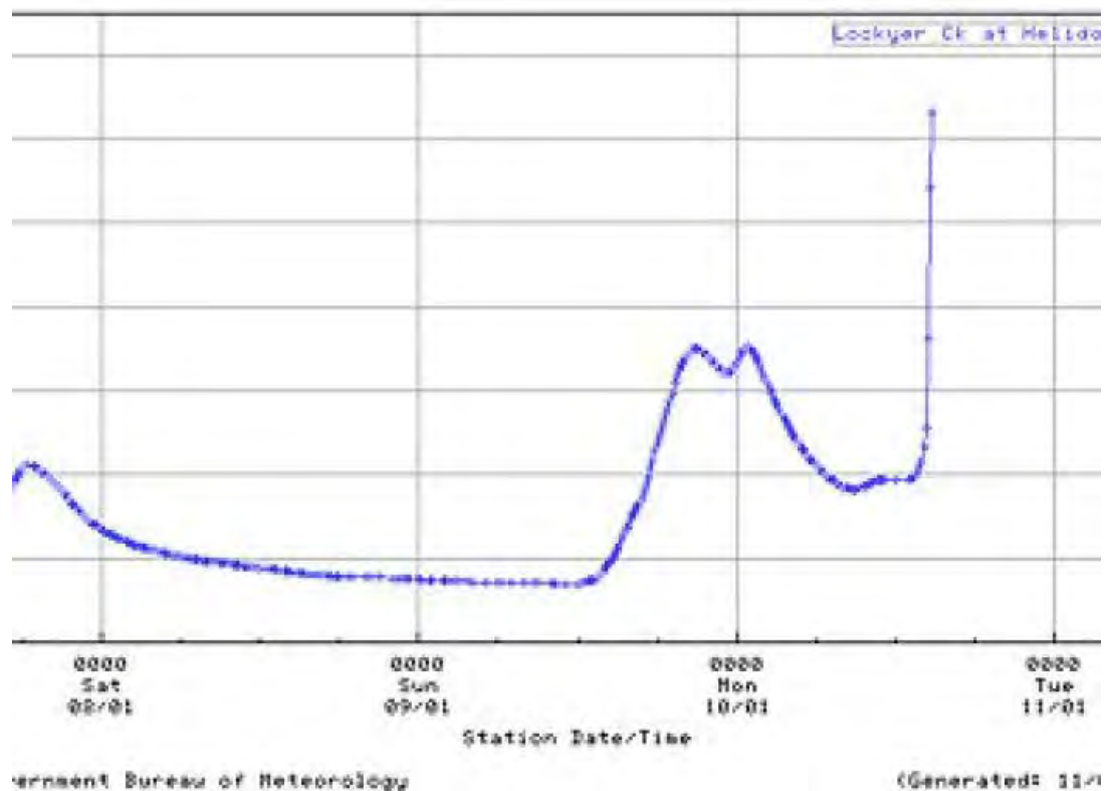
How much higher did Lockyer Creek rise at Helidon, if at all, and for how long was the maximum flow maintained before the level began to fall again?

Figure 0.4. Helidon Hydrograph, 10 January 2011. (Bureau of Meteorology, Queensland).

The photo series adds some of the missing information to the Helidon hydrograph that shot up from 4m to more than 13m and then stopped recording for some hours. The photos indicate the flood peak lasted much longer than previously thought.

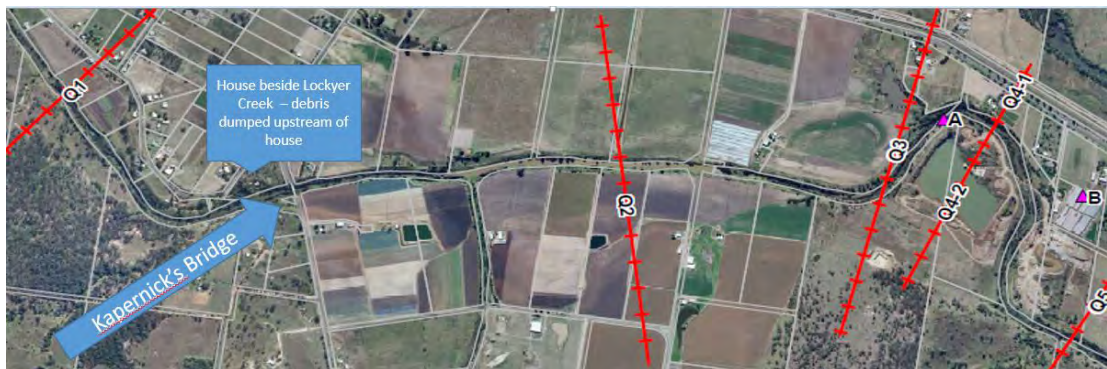
Evidence which supports the contention that water built up in the landscape west of the quarry includes the discovery of debris from a house west of Kapernick's Bridge that was found *upstream* of the house. This indicates there was a strong *backward* current at this location at the height of the flood.

Figure 0.6. Debris was dumped upstream of the house west of Kapernick's Bridge indicating a strong *backward* current at this location.

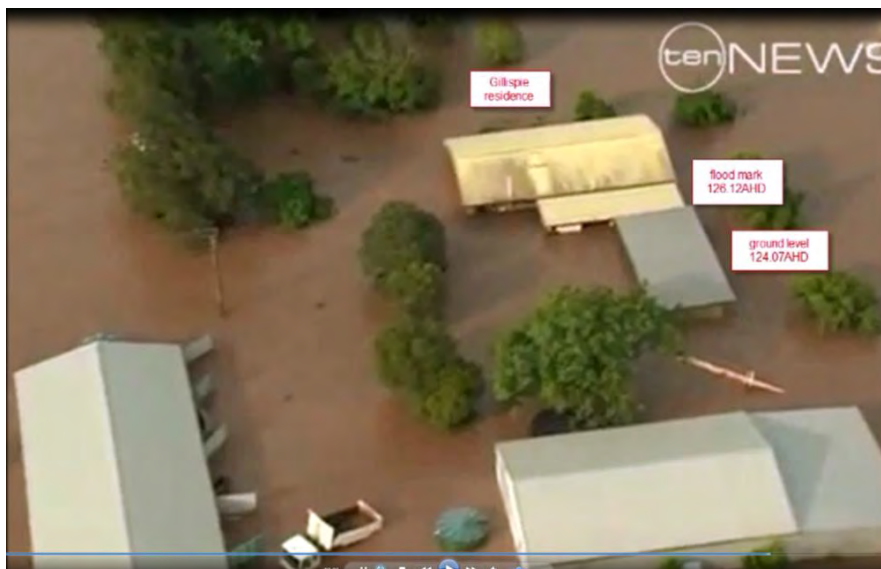
East of the quarry, the depth of the flood was several metres higher than estimated by the TuFlow model output, as indicated by the muddy residue to the top of the house roof.

Figure 0.8. East of the quarry: note the depth of the flood as indicated by the muddy residue to the top of the house roof.

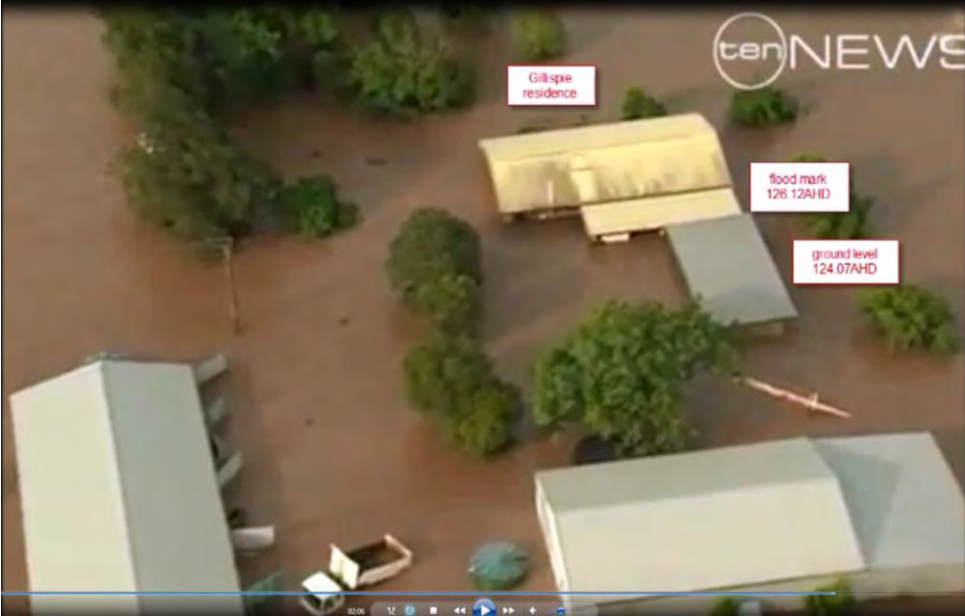
Aerial vision from Channel 7 and 10 news helicopters indicates the main force of the flood was directly across the quarry. The direction is indicated by the doors of the shed on Sean Gillespie’s shed (see Photograph below). The doors blew out and were left pointing directly towards Grantham.

Figure 0.10. Shed east of the quarry struck from the west, bursts open the doors. Note the direction of the doors which point directly towards Grantham.

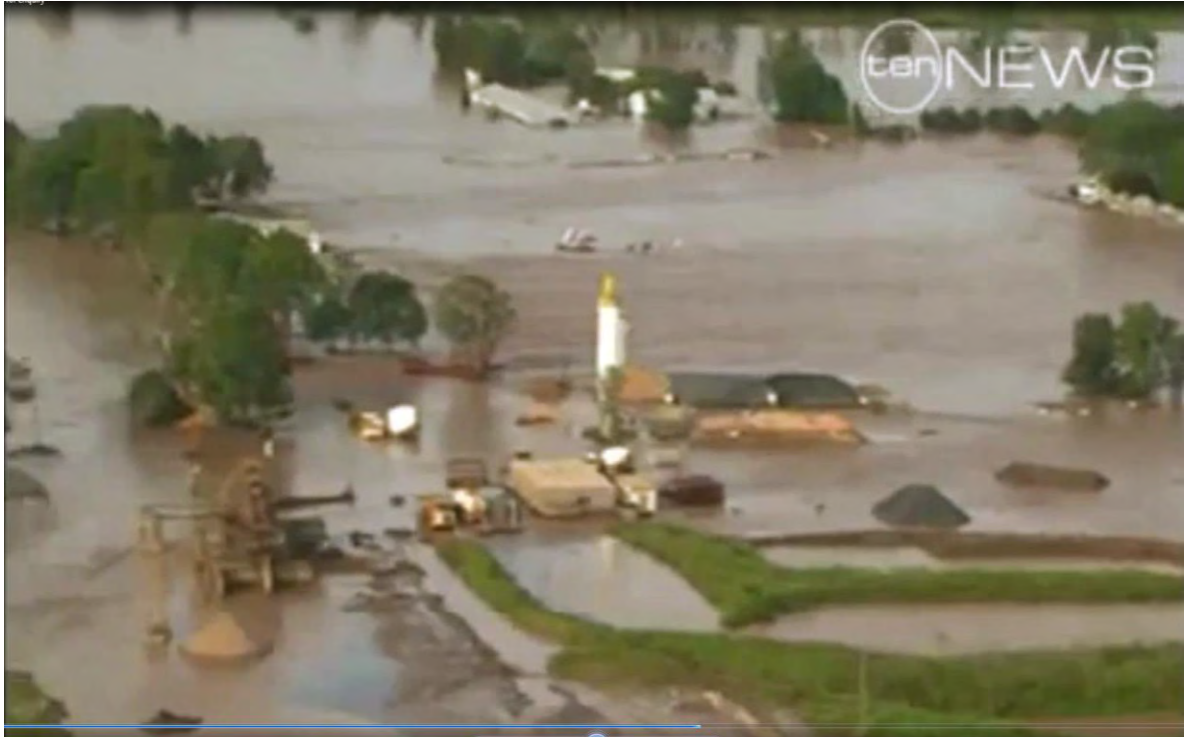
Figure 0.12. Video still: Sand batching plant at Grantham quarry. 10 January 2011. Note the piles of sand after the flood peak. (Source: Ten news aerial footage).

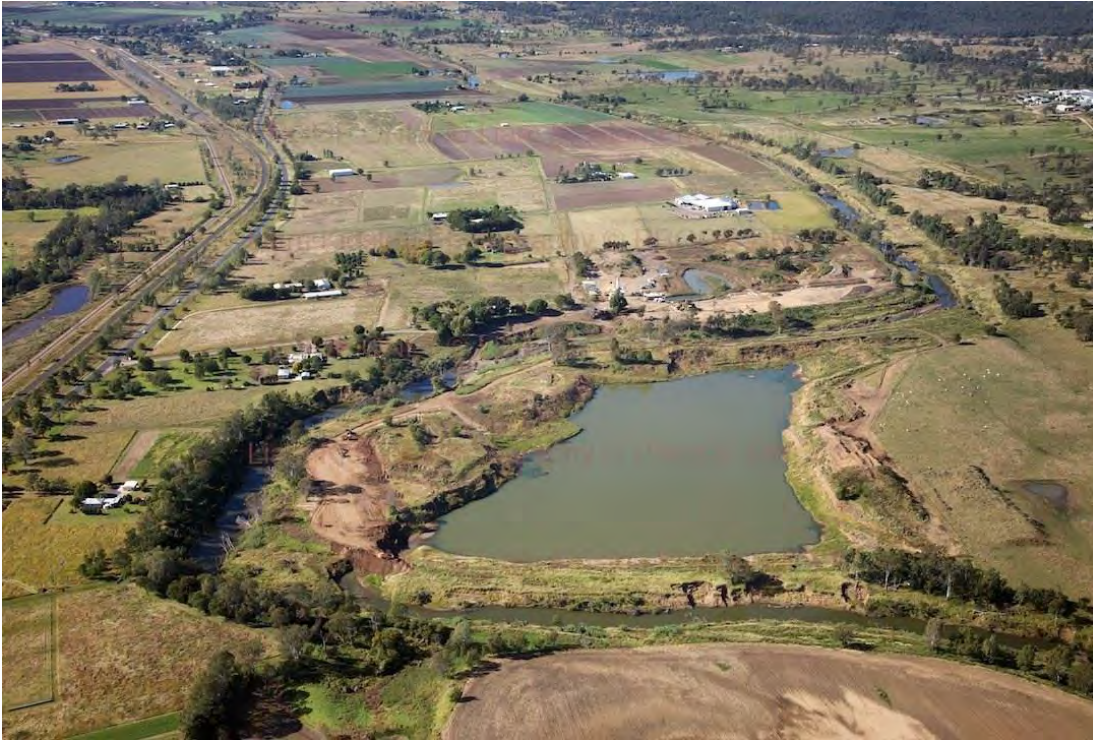
Figure 0.13. Grantham quarry: aerial May 2011. Note the area of earthworks on the northern side of the quarry where a section of remaining embankment is being taken away from what Denis Wagner claims publicly to be a ‘natural landscape’. (Source: The Courier-Mail)

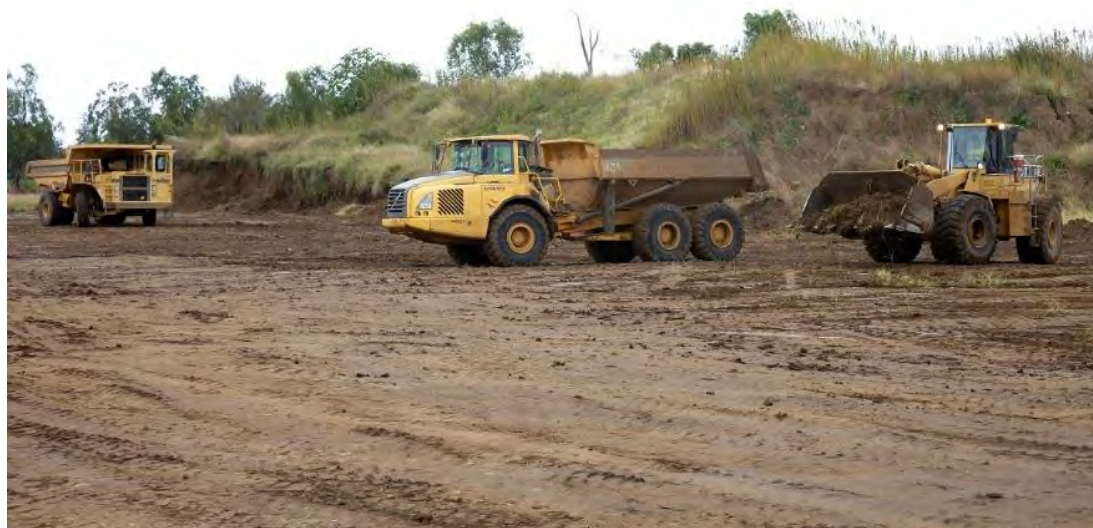
Figure 0.14. Grantham quarry. The same area as the aerial photo above. Note the height of the embankment compared with the dozer and trucks. (Source: The Courier-Mail)

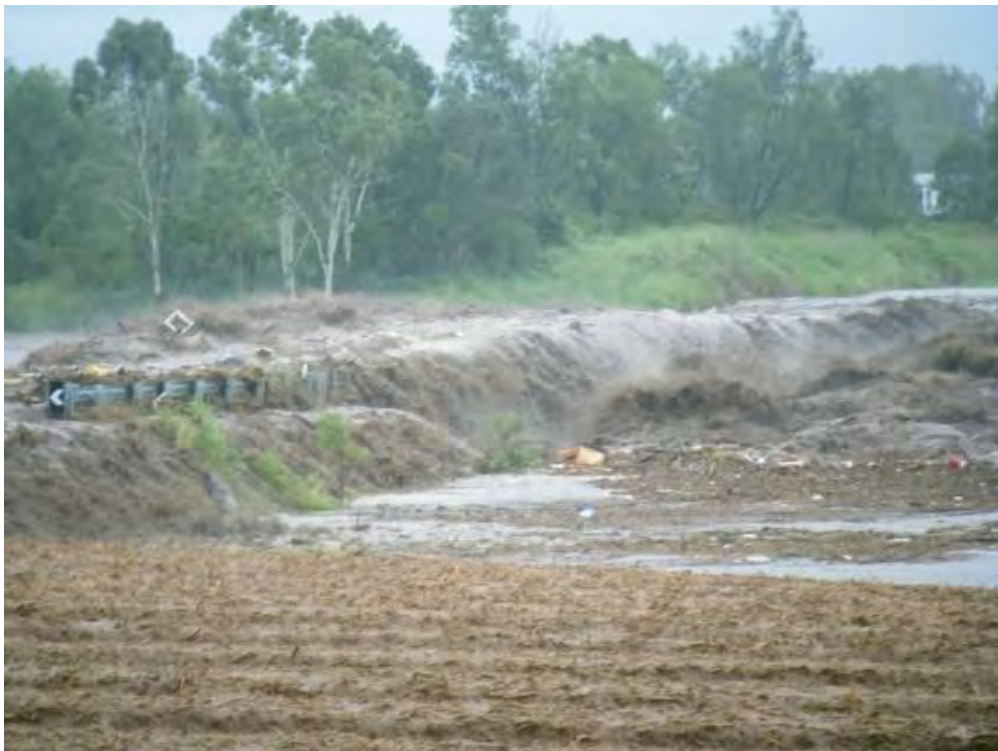
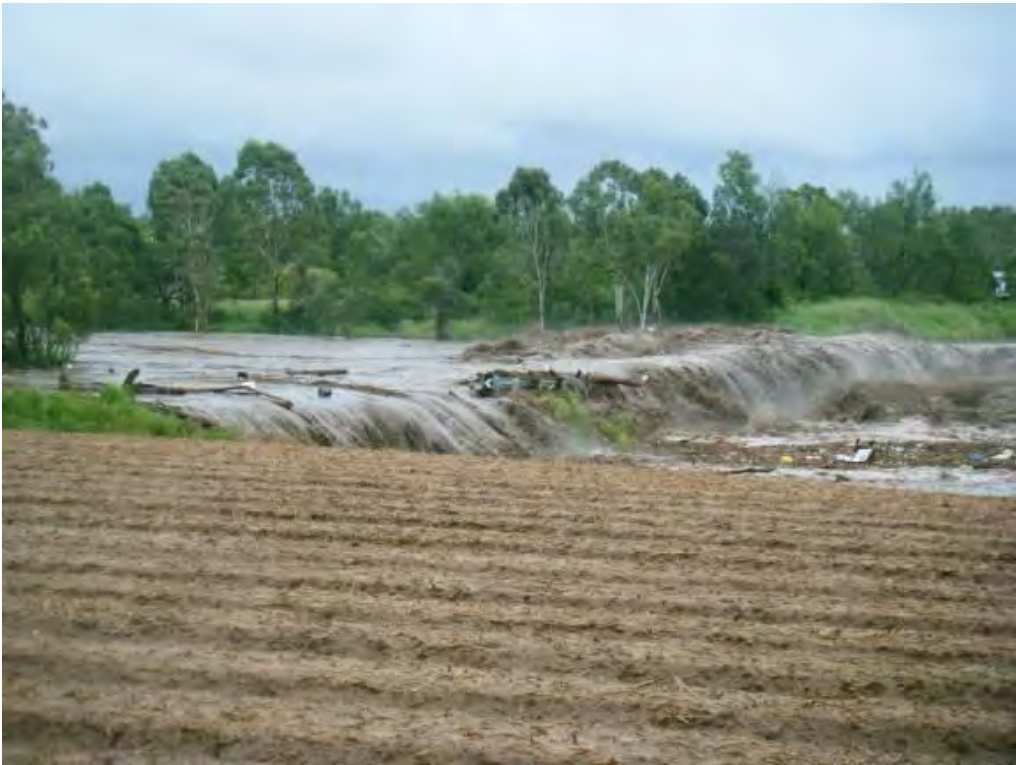
From this point in the sequence of photos, a large amount of floating debris begins to accumulate on top of the water. This indicates the water is not moving down the creek.

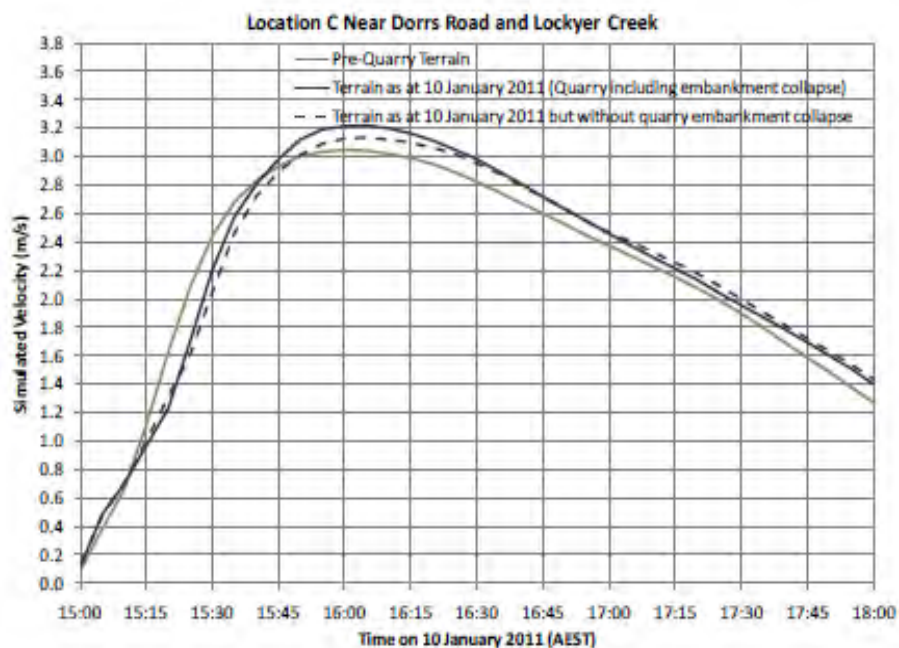
Figure 0.32. The graph shows the floodwater took an hour to rise to the maximum velocity and that the velocity fell slowly. Witnesses observed the water rise instantaneously, flow fast for about 20 minutes and then suddenly disappear back into the creek.

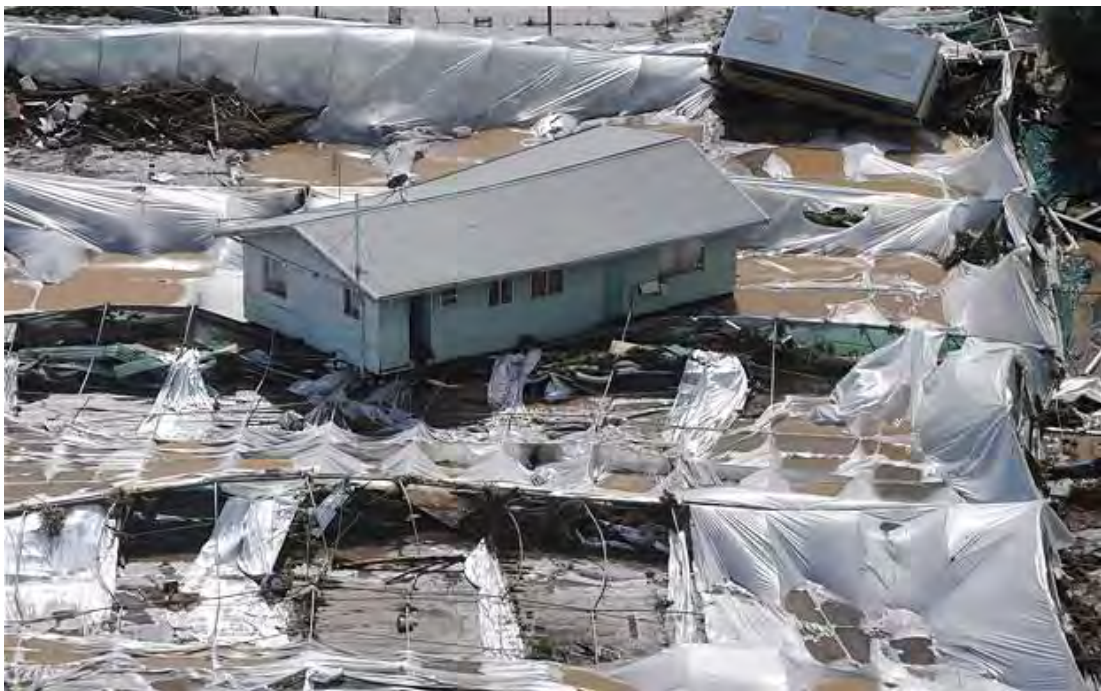
Figure 0.33. Wilkin's house was lifted from its stumps and swept across the road to the neighbouring flower farm where the greenhouses were destroyed.

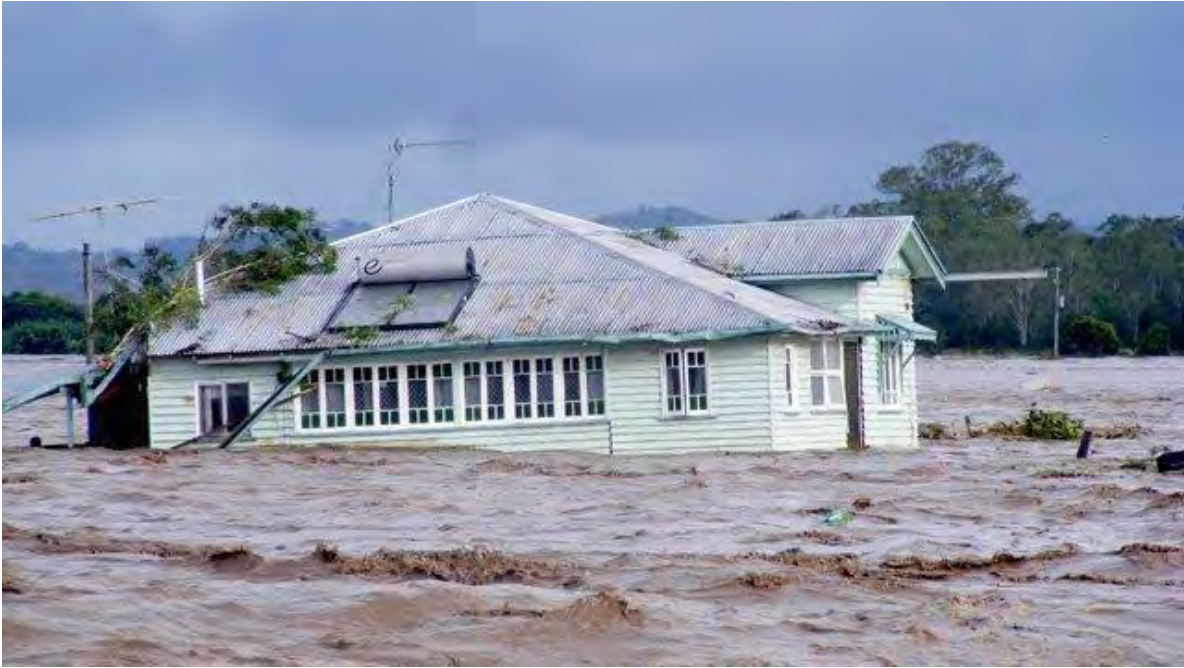
Figure 0.34. Peter and Marie van Straten’s house being swept from Anzac Avenue across Armstrong Road to a farm paddock 1.7km downstream.

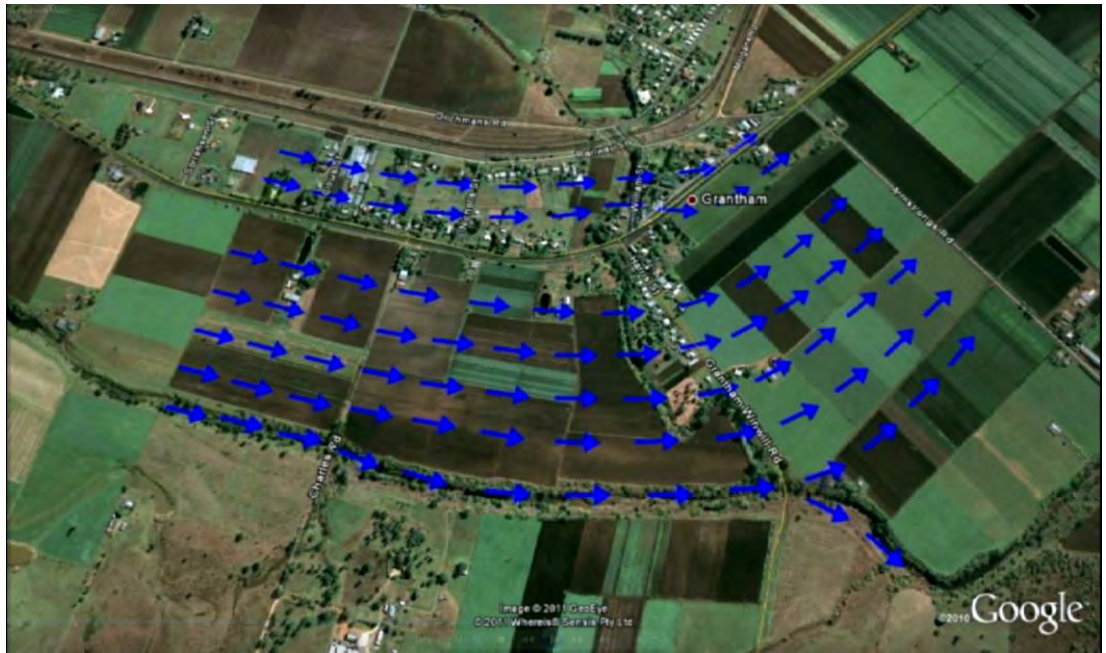
The direction of the torrent unleashed is clear from debris trails (as shown by the Taskforce Galaxy report).

Figure 0.35. Photograph: Taskforce Galaxy – Flood direction.

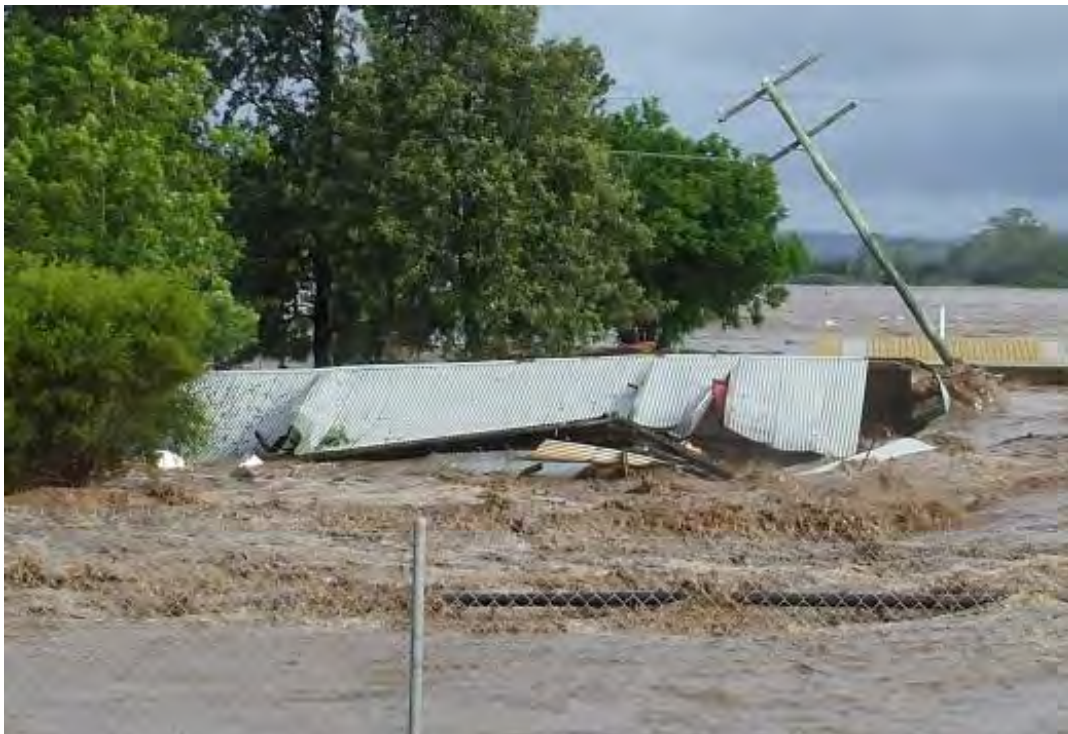
Figure 0.37. The torrent: Water speed, depth and turbulence indicate the very fast and dangerous torrent which struck buildings and people in Grantham.

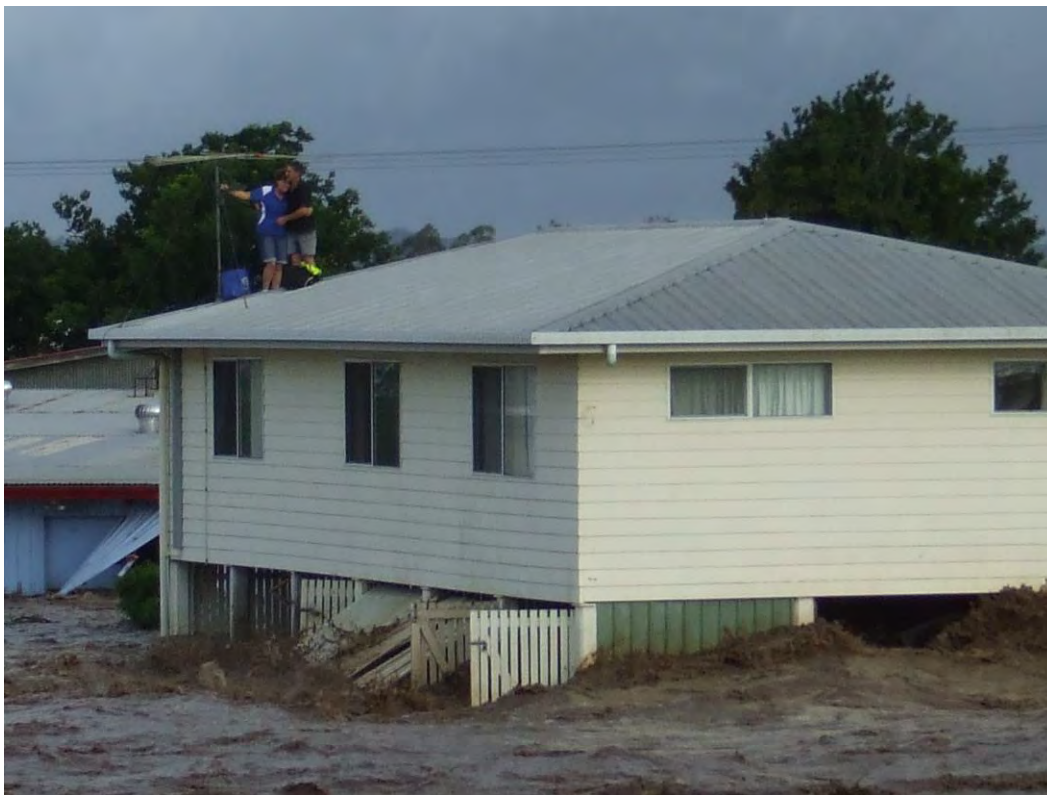
Figure 0.38. Depth, turbulence and speed of the flood water at the house behind the shop in Anzac Avenue meant rescuing anyone during the height of the flood by boat was impossible. (Source: Bess Fraser)
